TRANSPORTATION RESEARCH
CIRCULAR

Perpetual Bituminous Pavements

TRB Committee on General Issues in Asphalt Technology (A2D05)

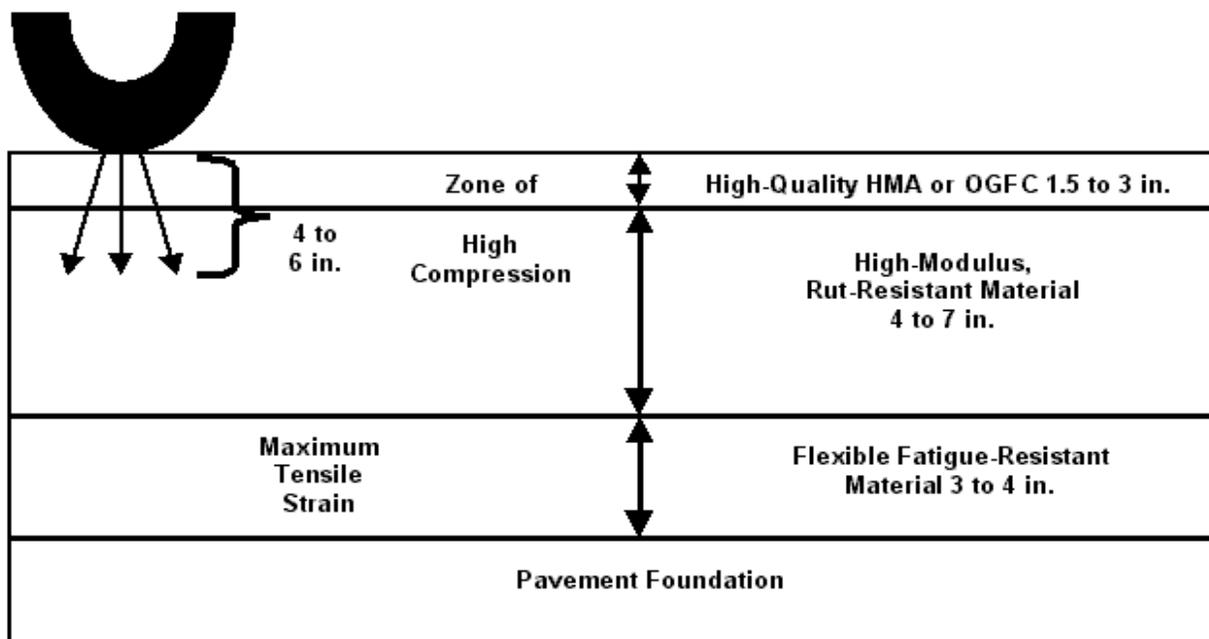
FIGURE 1 Perpetual pavement design concept (HMA = hot-mix asphalt).

Recent efforts in materials selection, mixture design, performance testing, and pavement design offer a methodology which may be employed to obtain long-lasting performance from asphalt pavement structures (greater than 50 years) while periodically (approximately every 20 years) replacing the surface of the pavement. This concept has been proposed by Nunn et al. of the Transport Research Laboratory in the United Kingdom (3). The California Department of Transportation, with the assistance of a research team at the University of California, Berkeley, is planning the rehabilitation of a concrete freeway near Long Beach using the concept of a perpetual asphalt pavement as an overlay to the broken and seated concrete (4). Finally, Von Quintas proposed this approach in the rehabilitation of the southeast corridor in Denver (5). The common theme in these approaches is to combine a rut resistant, impermeable, and wear resistant top structural layer with a rut resistant and durable intermediate layer and a fatigue resistant and durable base layer (Figure 1). For areas where the use of an open-graded friction course is desired, this feature can be incorporated and viewed as a renewable wearing course.

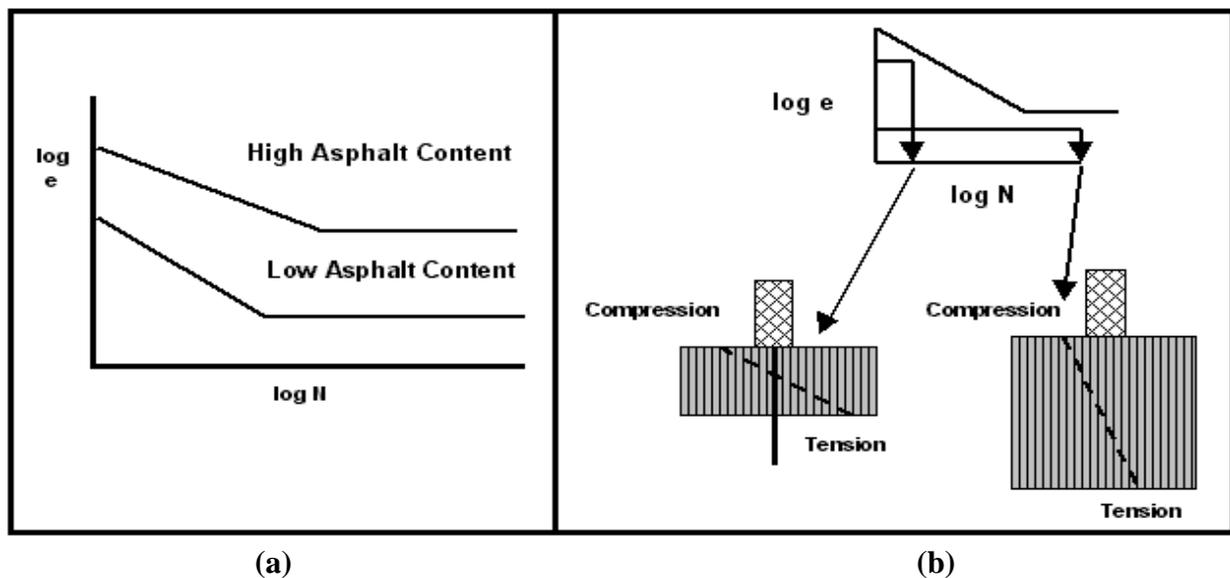
FIGURE 2 Fatigue resistant asphalt base: (a) improve fatigue resistance with high asphalt content mixes, and (b) minimize tensile strain with pavement thickness ($\log e = \log$ of strain; $\log N = \log$ of number of cycles to failure).

The base layer of HMA must resist the tendency to fatigue crack from bending under traffic loads. The main mixture characteristic which can help guard against fatigue cracking is a higher asphalt content (Figure 2a). The use of a finer aggregate gradation can also make a mixture more fatigue resistant. These characteristics, in combination with an appropriate total asphalt thickness, will provide insurance against fatigue cracking from the bottom layer (Figure 2b). Durability of this layer will be provided primarily by the higher asphalt content.

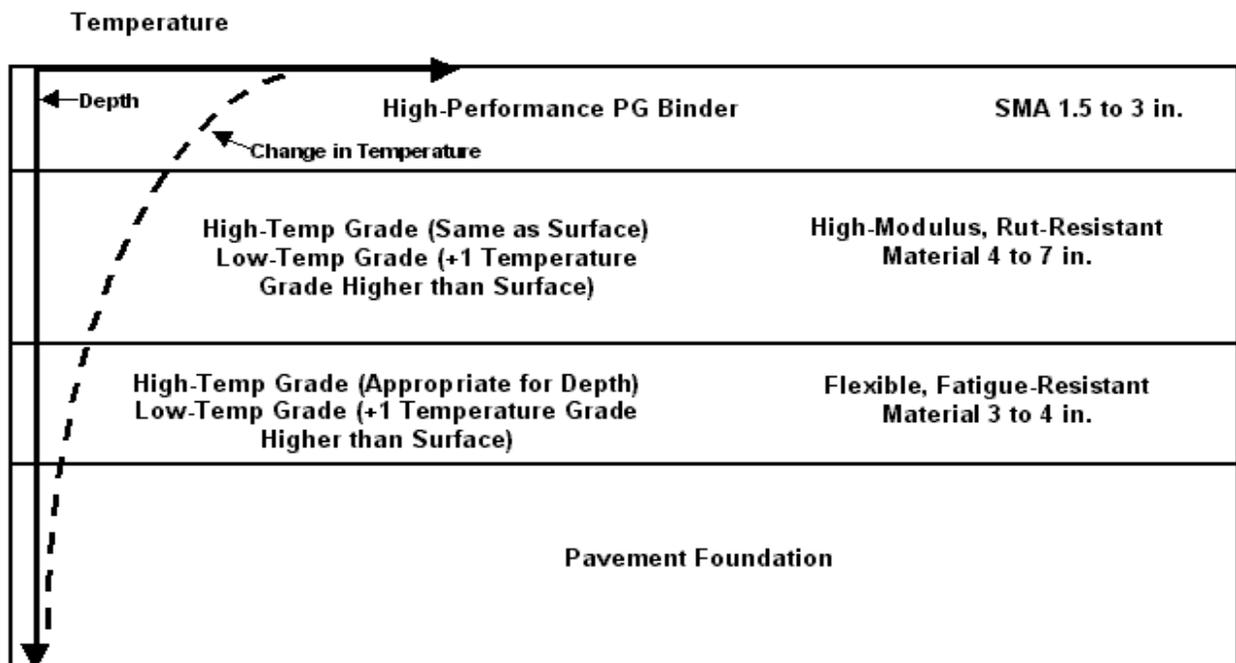
FIGURE 3 Impact of temperature gradient on asphalt grade (PG = performance grade).

Depending upon climate, to avoid rutting the performance grade should be bumped to at least one high temperature grade greater than normally used in an area. The low temperature grade should be that normally used in the area for perhaps a 95 or 99 percent reliability in resisting thermal cracking.

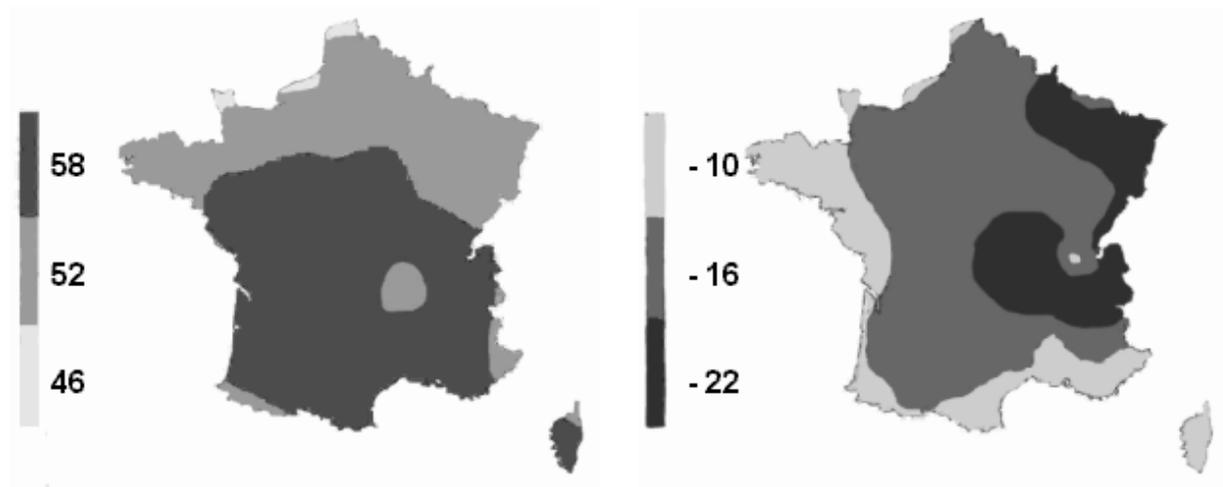
FIGURE 1 Maps of France PG pavement temperatures.

In order to relate France's climatic conditions to the SUPERPAVE approach, Figure 1 shows two maps of France for low and high temperatures with indication of the penetration grade (PG) for the asphalt binder.

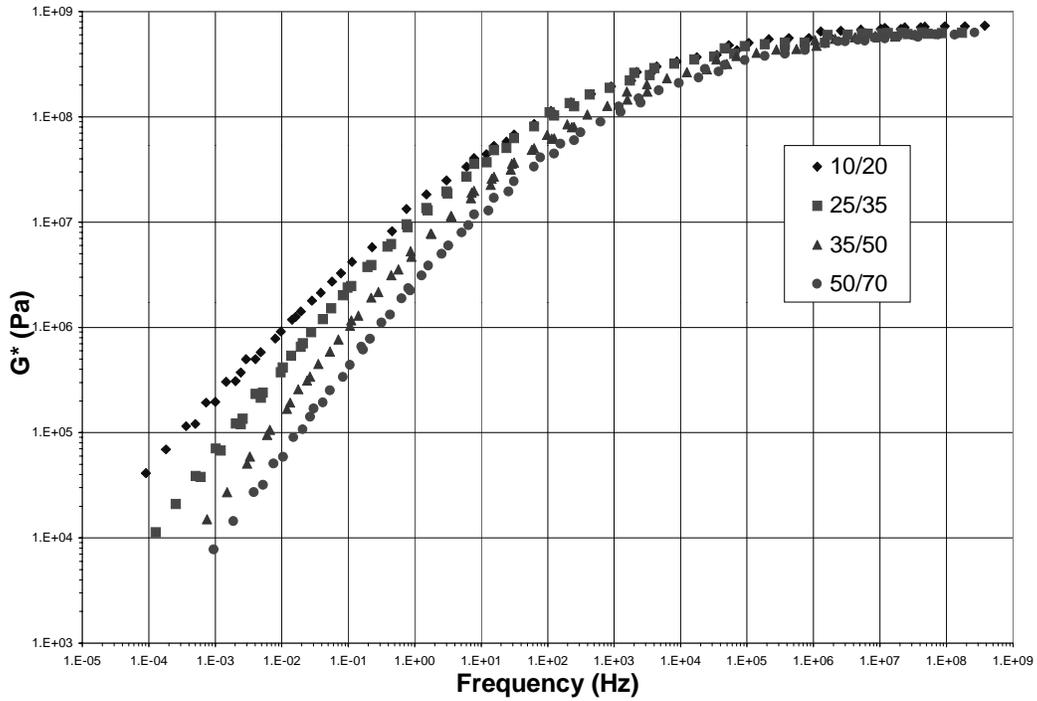
FIGURE 2 Master curves of complex modulus G^* of four different asphalts: 10/20, 25/35, 35/50, and 50/70 penetration grades.

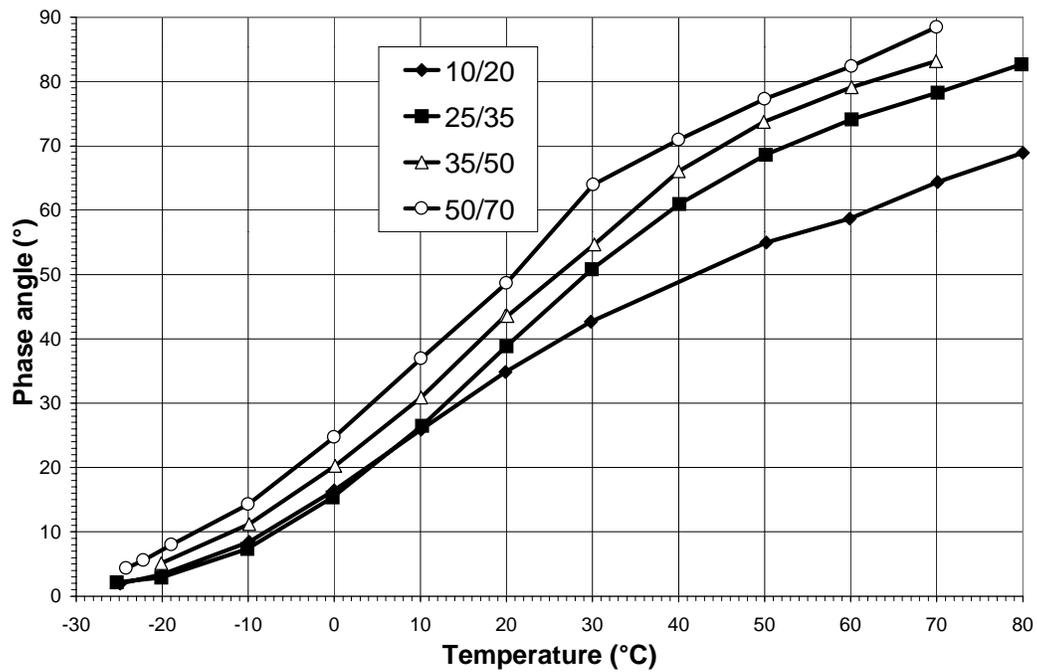
FIGURE 3 Variation of phase angle with temperature at 7.8 Hz for four different asphalts: 10/20, 25/35, 35/50, and 50/70 penetration grades.

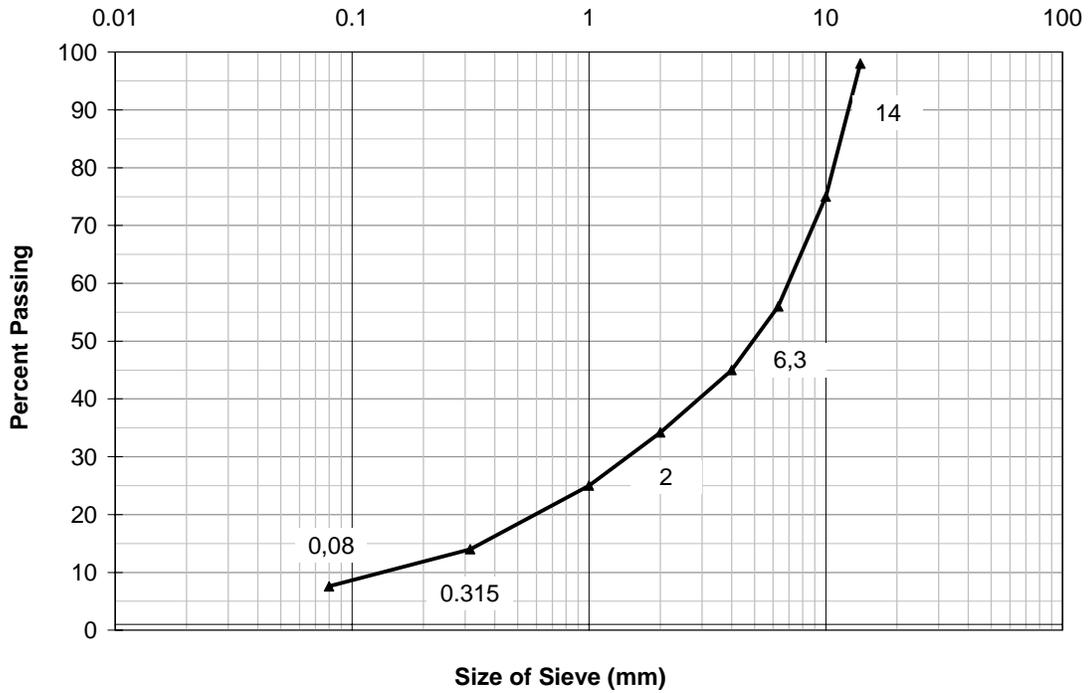
FIGURE 4 Sieve analysis = typical grading for a 10/14mm HMAC with 6.2 percent asphalt content.

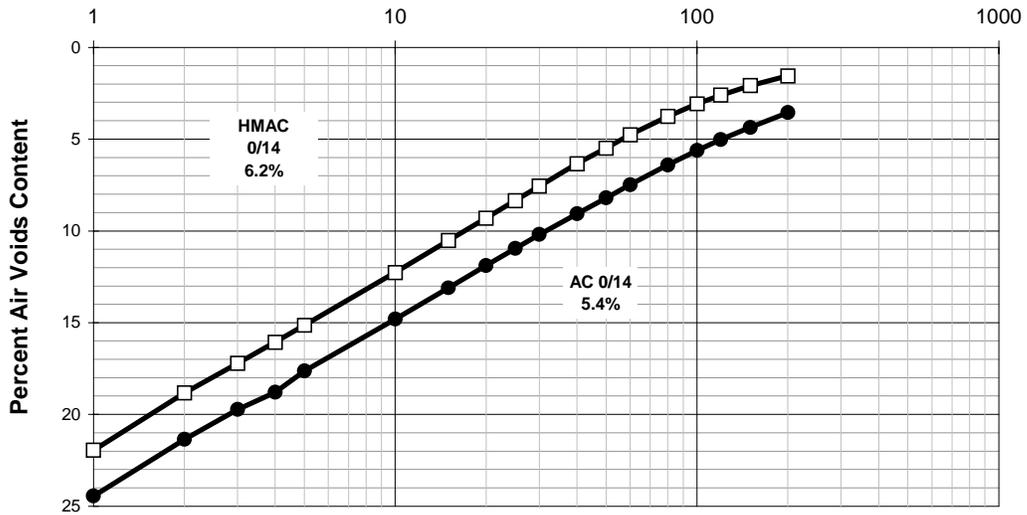
FIGURE 5 Gyratory shear compaction tests: comparison between HMAC and a traditional base asphalt concrete.

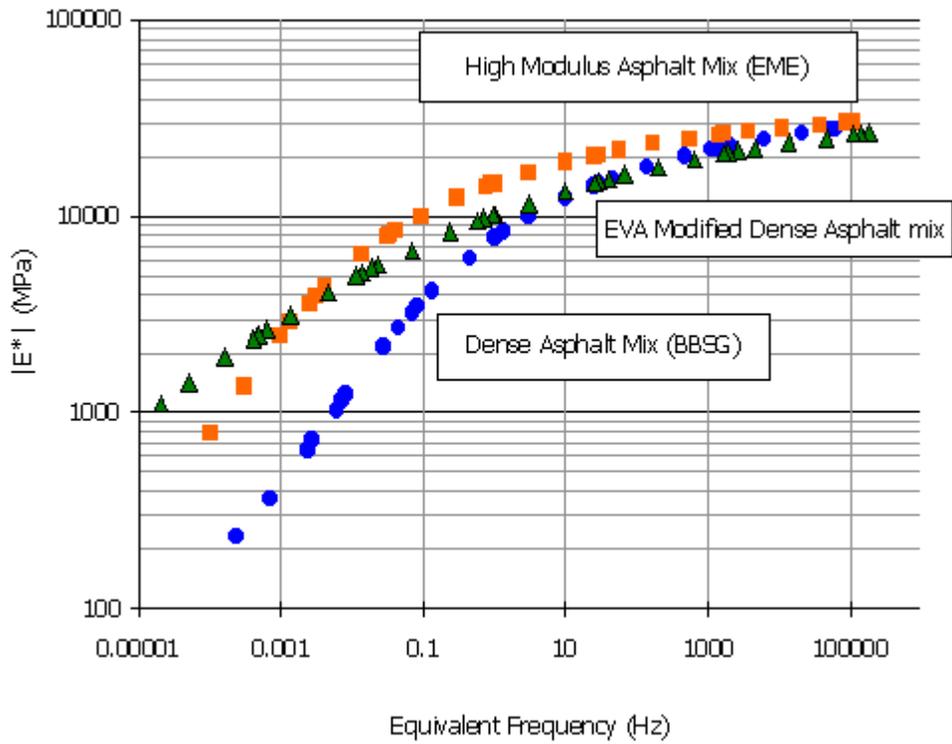
FIGURE 6 Complex modulus master curves on three different asphalt mixes (BBSG = Béton Bitumineux Semi-Grenu).

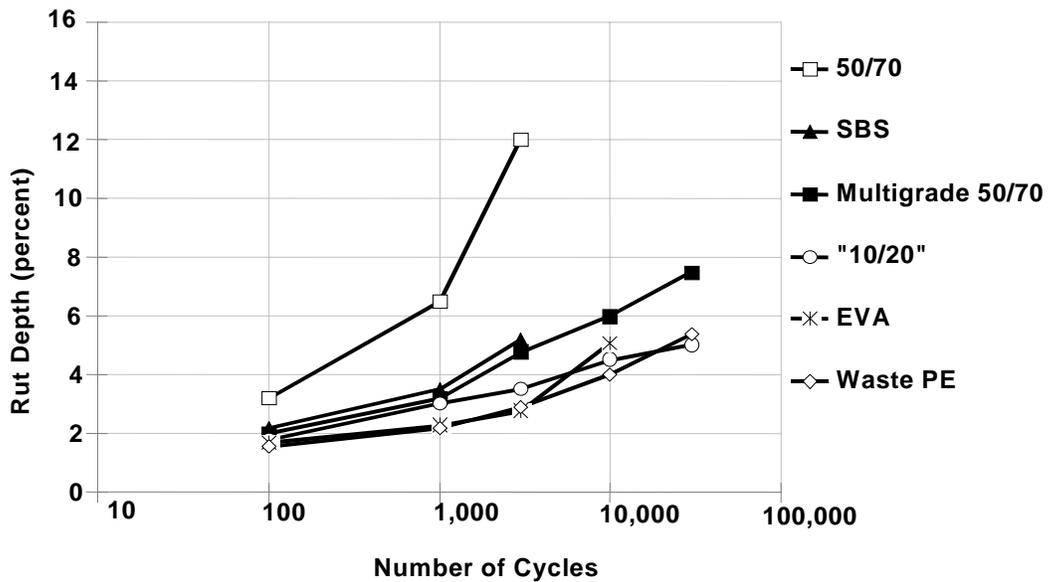
FIGURE 7 Wheel-tracking test results showing the influence of the asphalt binder on the resistance to rutting of similar AC mixes (PE = polyethylene).

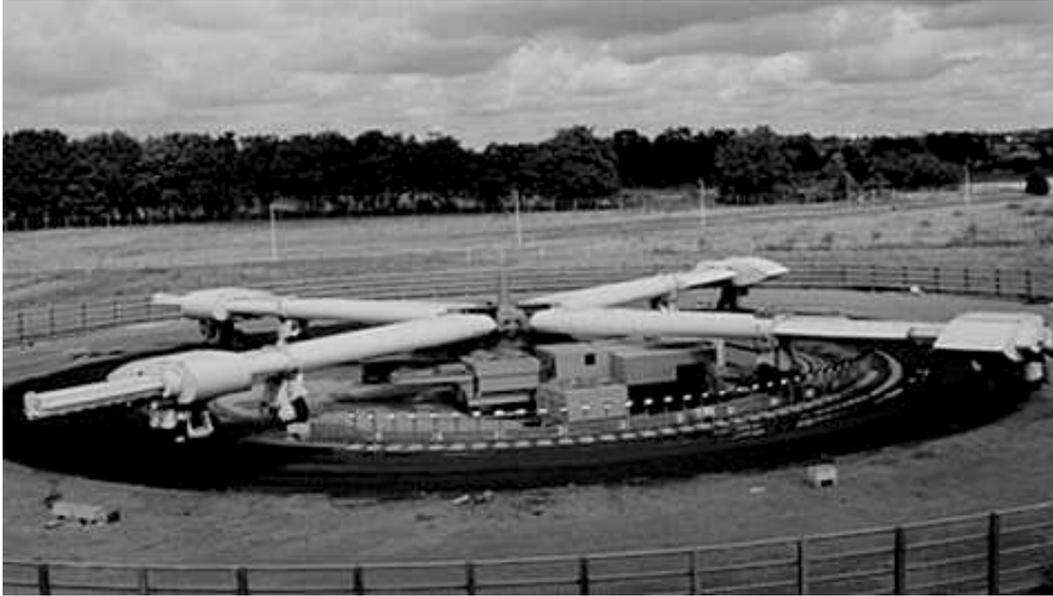
FIGURE 8 View of LCPC's accelerated pavement testing facility.

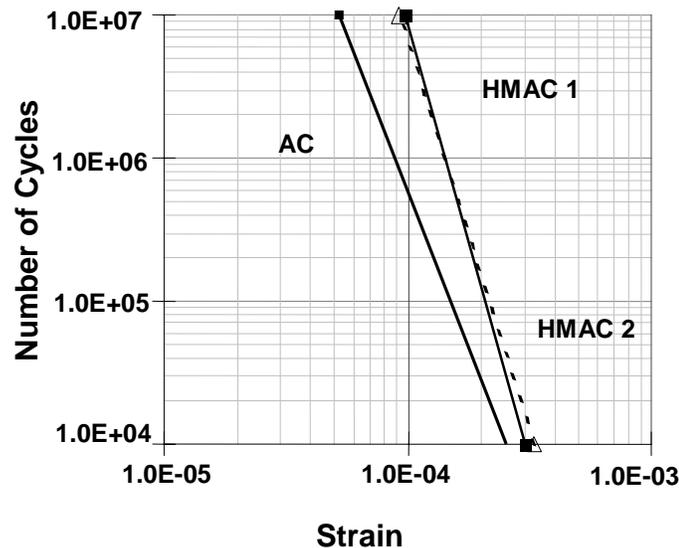
FIGURE 9 Two-point bending fatigue tests (one traditional base AC, two HMACs having the same composition but different hard asphalt).

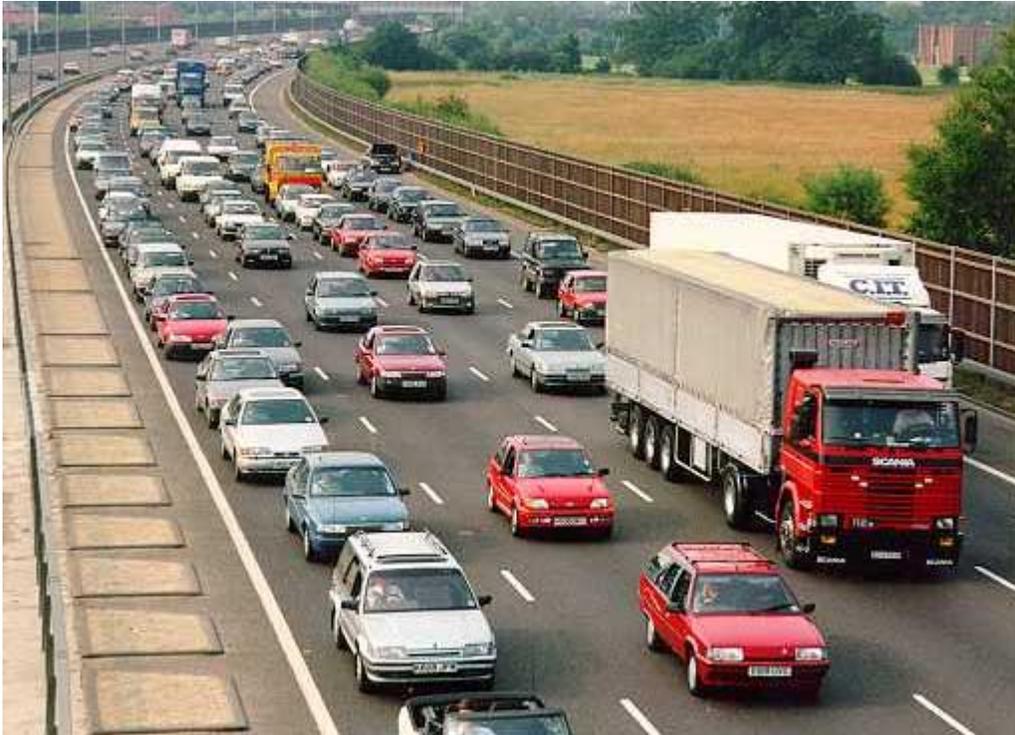
FIGURE 1 Disruption to road users on heavily trafficked roads.

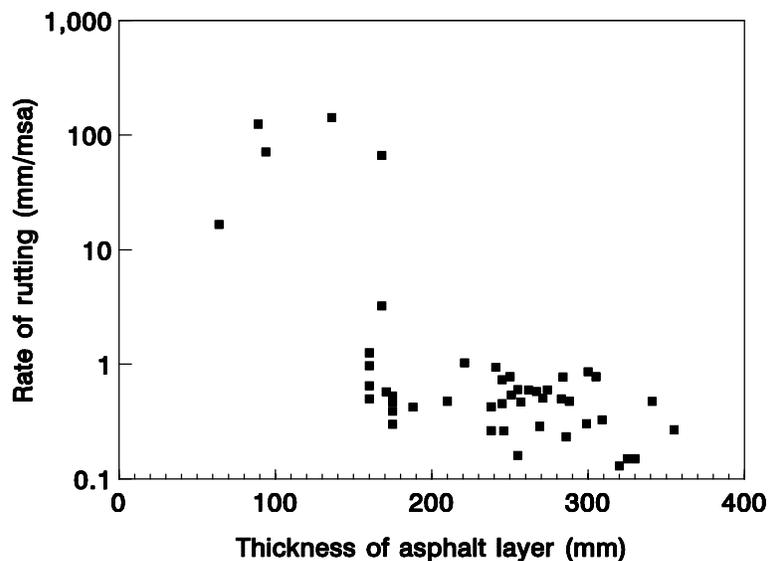
FIGURE 2 Rate of rutting of trunk roads.

A summary of mean rates of rutting of asphalt pavements is shown in Figure 2. The figure indicates a discontinuous relationship between the rate of rutting and pavement thickness, with data forming in two clusters. Pavements with less than about 180 mm of asphalt material deform at a high rate, but thicker pavements deform at a rate about two orders of magnitude less; the sudden transition suggests a threshold effect.

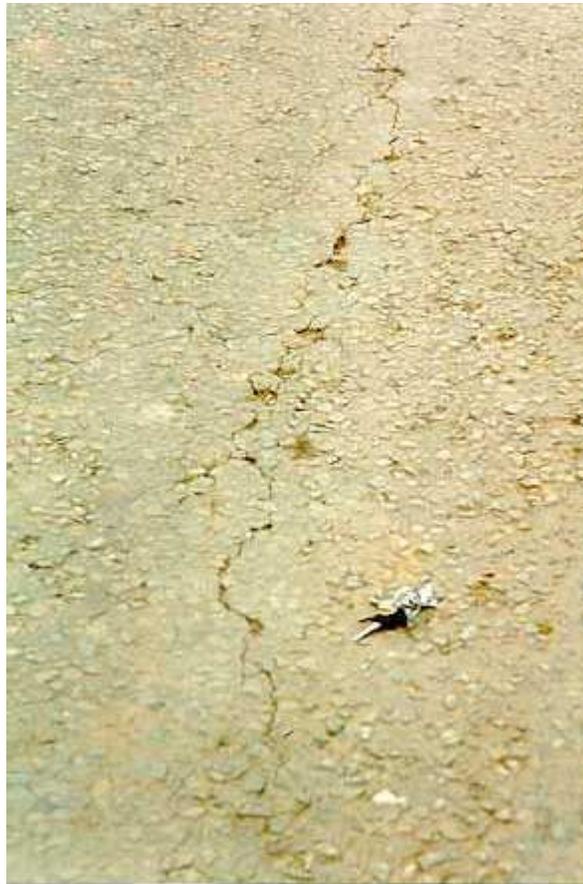
FIGURE 3a Longitudinal cracking in the near-side wheelpath of the M1 site.

Surface cracking is not always longitudinal. At other sites transverse cracks occurred in all lanes of each carriageway, and they were not confined to wheel tracks. As with longitudinal cracking, transverse cracks generally penetrated only up to 100 mm into the surfacing.

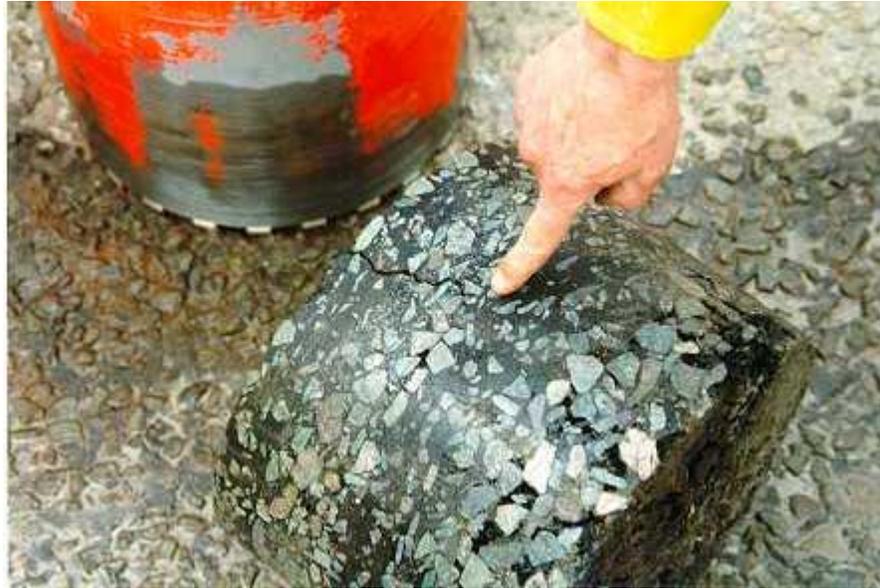
FIGURE 3b Longitudinal cracking in the near-side wheelpath of the M1 site.

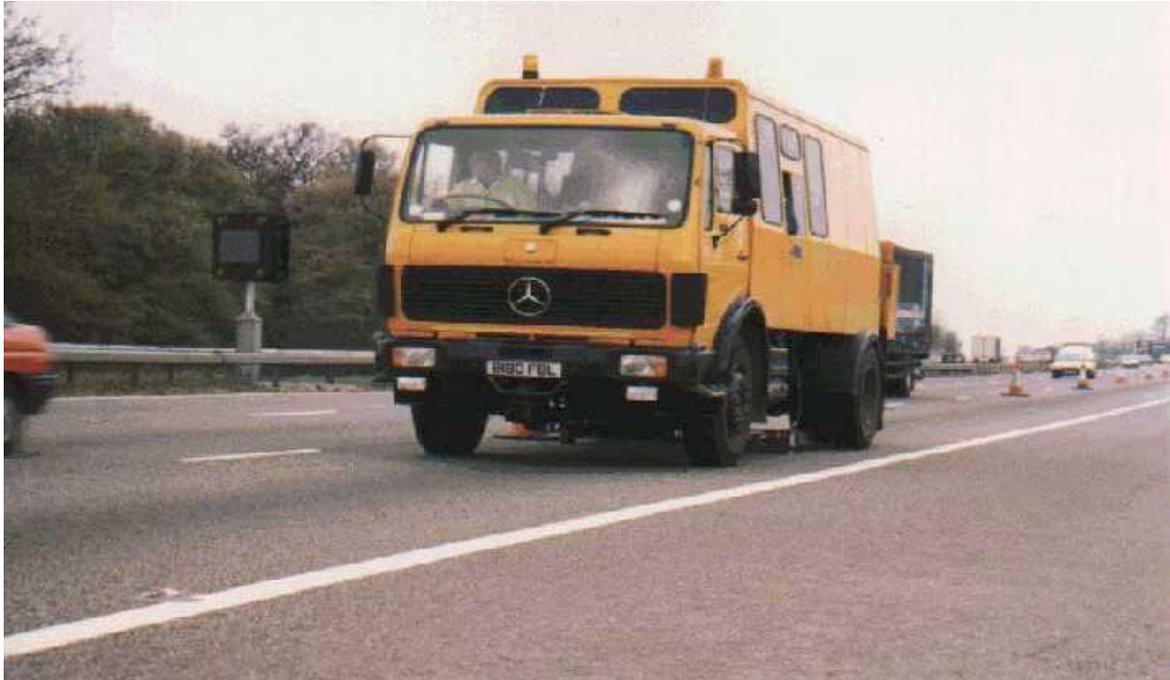
FIGURE 5 Deflectograph survey in progress.

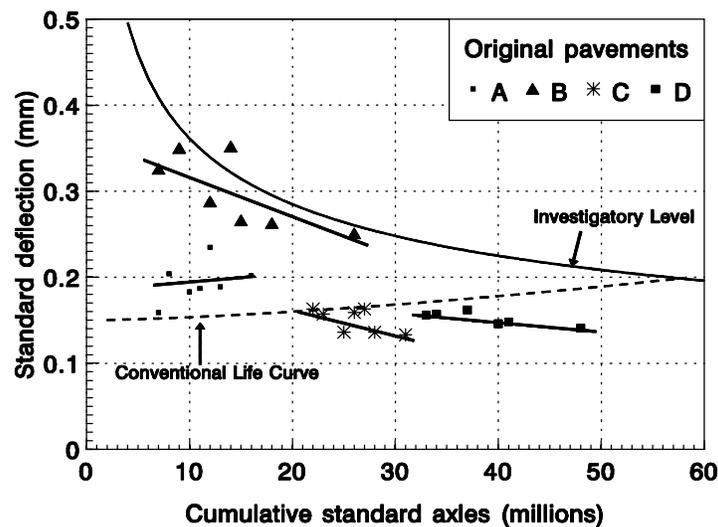
FIGURE 6 Deflection histories of in-service motorways—deflectograph measurements.

With one exception, which shows no decisive trend either way, all the sections show a trend of steady or decreasing deflection with age and traffic. These decreases imply that the overall stiffnesses of the pavements are increasing over time and that any traffic-related deterioration is more than offset by curing of the road base or strengthening of the foundation. For whatever reason, the road is becoming stiffer with time, and, hence, the traffic-induced stresses and strains in the road base and the subgrade, which are considered to be responsible for structural deterioration, are decreasing.

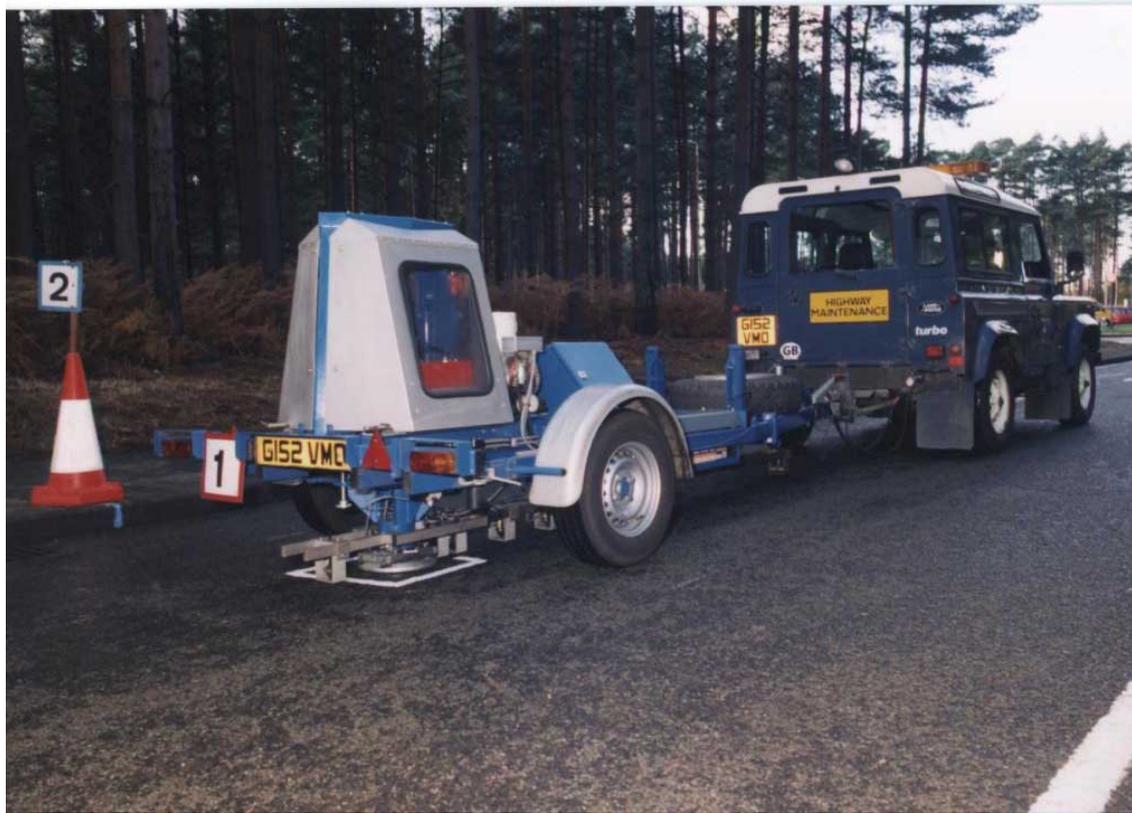
FIGURE 7 FWD carrying out measurements.

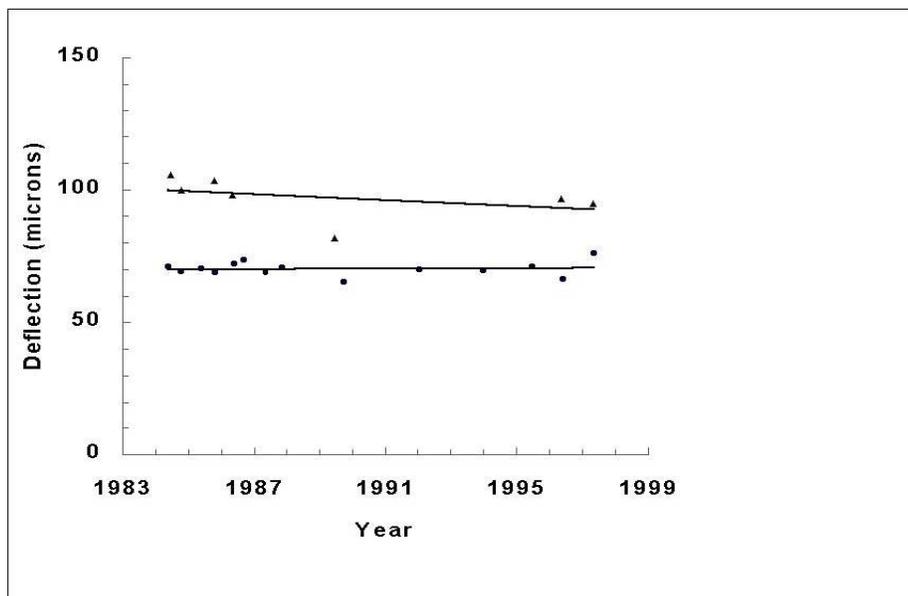
FIGURE 8 Deflection histories of in-service motorways—FWD measurements.

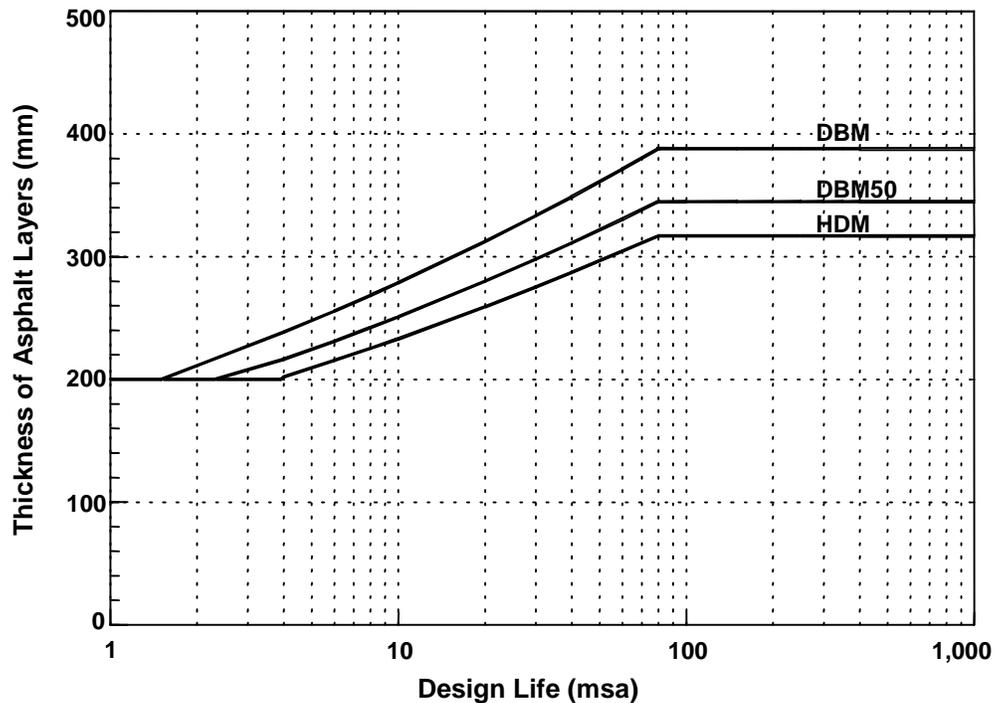
FIGURE 9 Design curve to include long-life pavements.

These designs will have built-in conservatism, but some conservatism can be justified, considering the economic importance of these roads. A thickness of less than 200 mm for the asphalt paving is not recommended even for lightly trafficked roads that are required to endure for 40 years. Thin roads may be at risk of structural deformation and rapid propagation of surface-initiated cracks through the full thickness of asphalt.

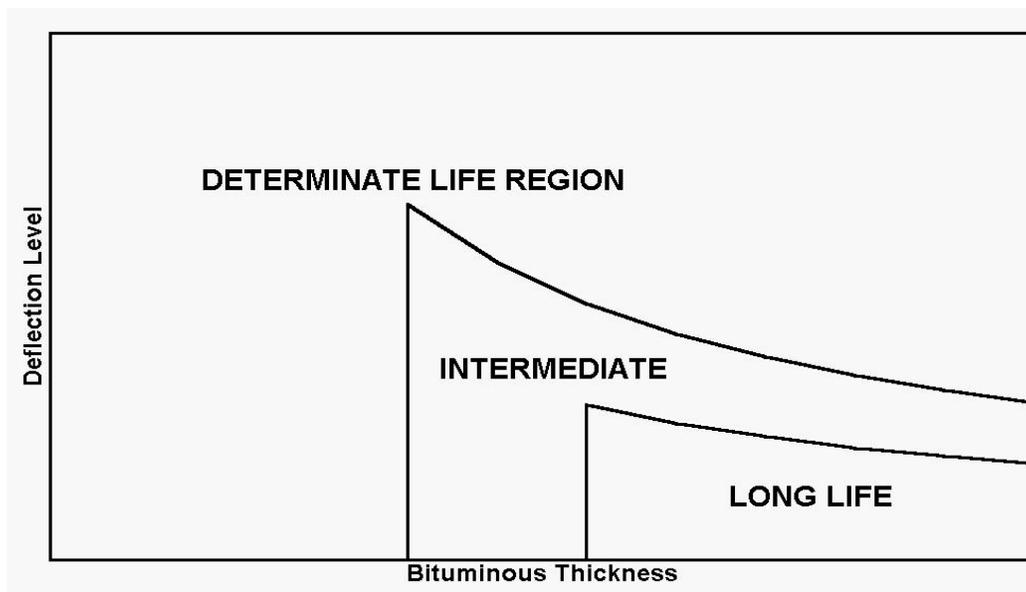
FIGURE 10 Provisional chart for preliminary identification of in-service long-life pavements.

On the basis of the observed behaviour of such pavements, criteria to identify long-life in-service pavements on the network can be identified from deflection measurements in conjunction with their layer thicknesses as shown in Figure 10. The main long-life zone may be delineated by

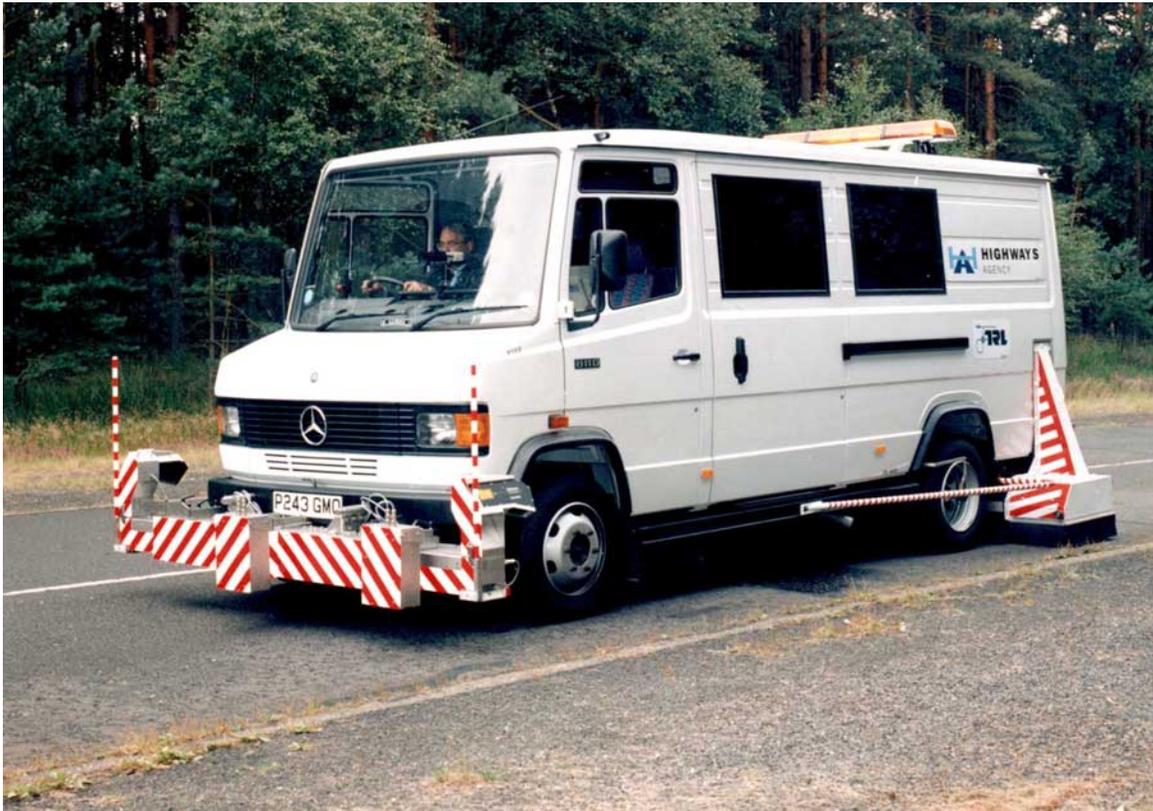
FIGURE 11 HARRIS survey system.

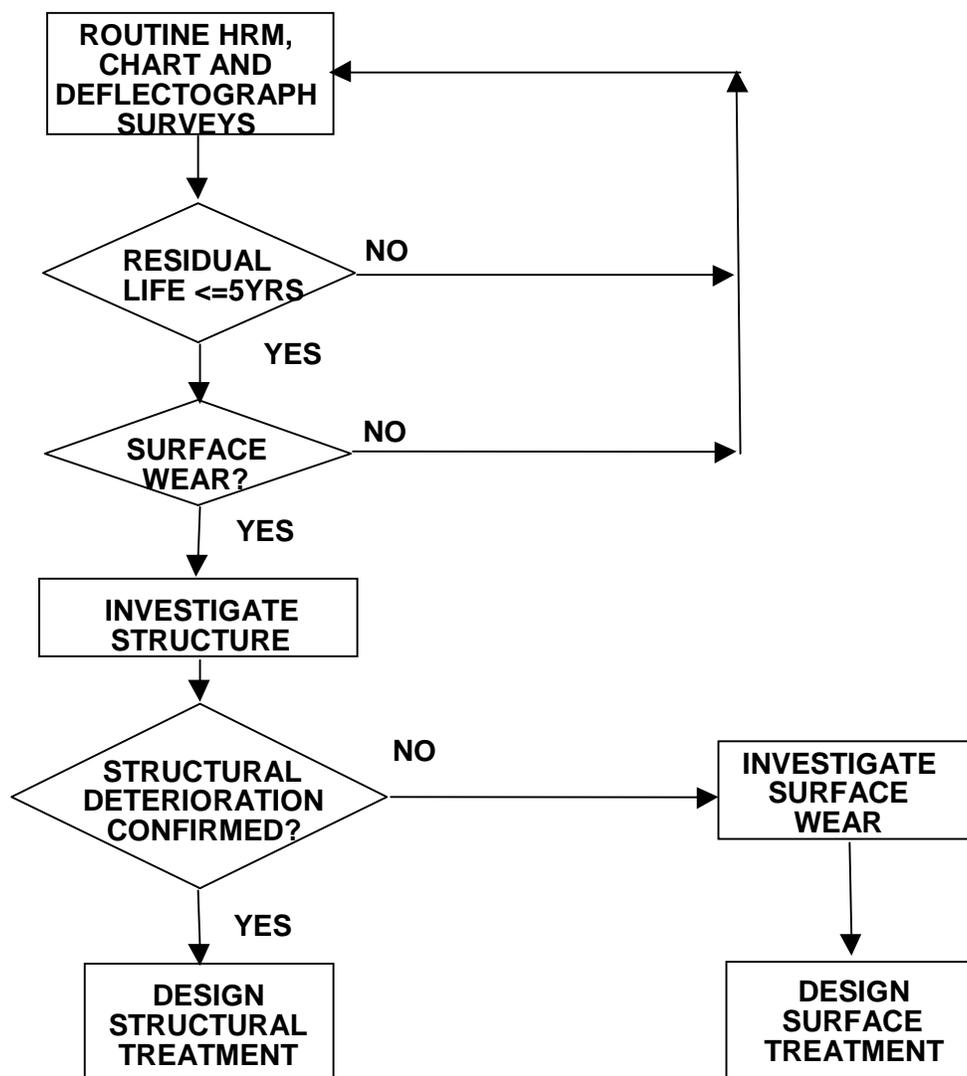
FIGURE 12 Current structural assessment procedure (HRM = high-speed road monitor).

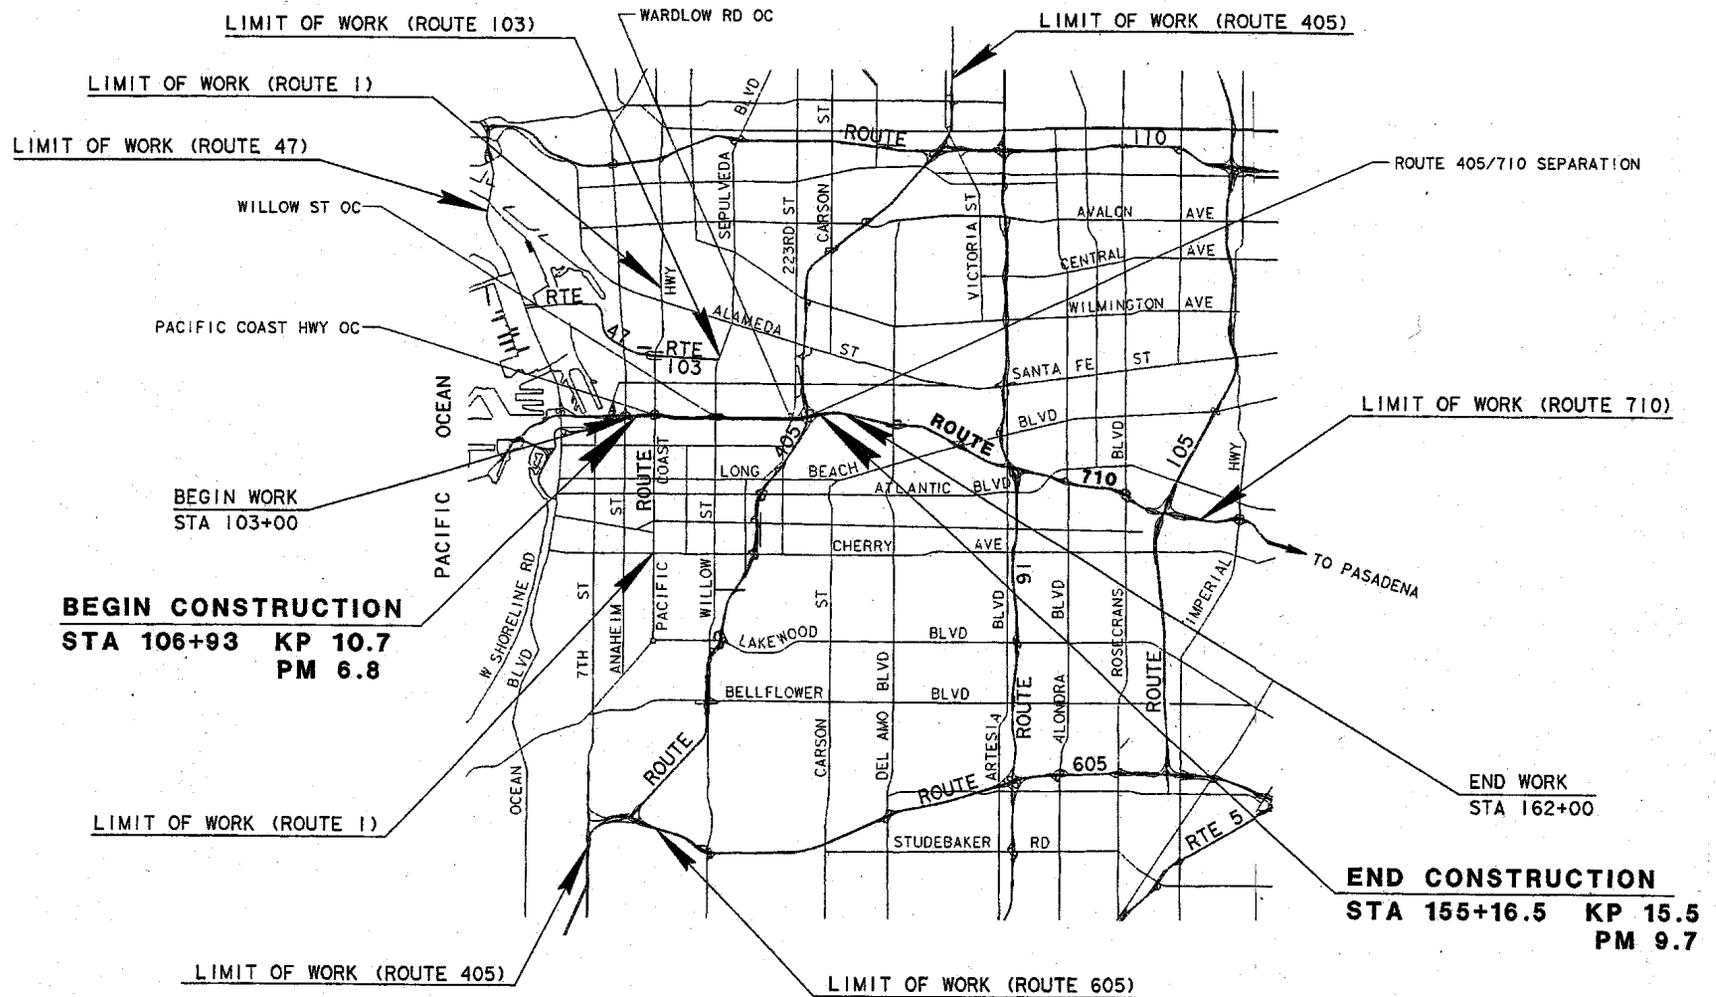
FIGURE 1 Portion of I-710 scheduled for rehabilitation (OC = overcrossing, STA = station, KP = kilometer post, PM = post mile).

The existing pavement structural section consists of 200 mm (8 in.) of portland cement concrete (PCC), 100 mm (4 in.) of cement treated subbase, 100 mm (4 in.) of aggregate base and 200 mm (8 in.) of imported subbase material. Two rehabilitation strategies have been selected, one for the majority of the section and the other for under the structures. On the sections where the overhead clearance is acceptable, the existing PCC will be cracked and seated and overlaid

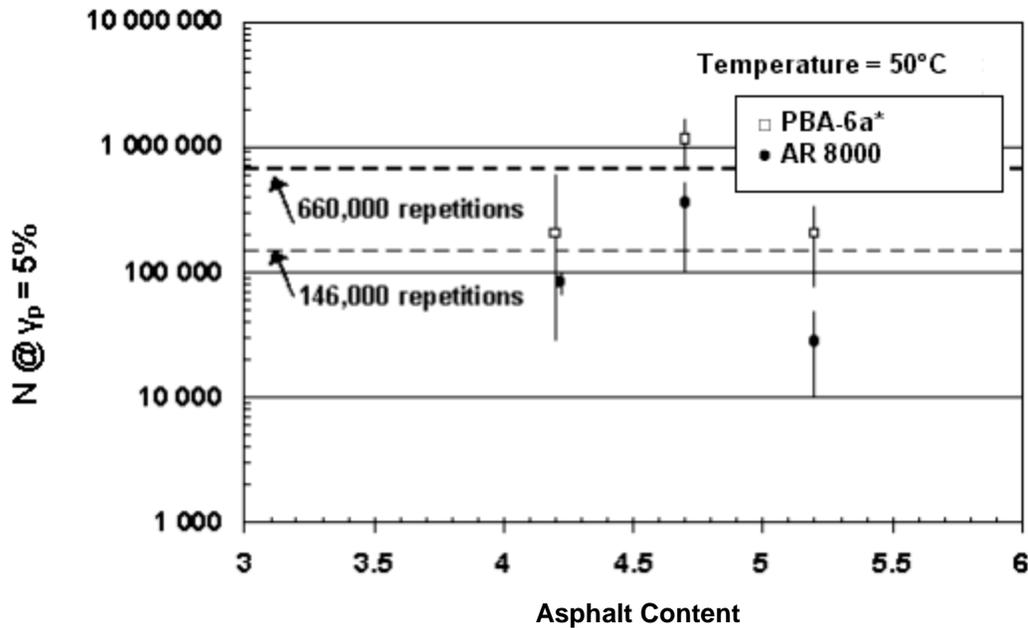
FIGURE 2 RSST-CH repetitions to 5 percent permanent shear strain versus binder content (percent by weight of aggregate).

Results of the RSST-CH obtained at 50°C (122°F) were used to select the binder contents for the two mixes. Essentially, the mix design consisted of selecting the highest binder content which permits the mix to accommodate the design traffic at the critical temperature [in this case 50°C (122°F)] without exceeding a limiting rut depth of 12.5 mm (0.5 in.) (4). Results of the RSST-CH tests are shown in Figure 2 together with associated traffic repetitions at 50°C (122°F) converted to equivalent laboratory repetitions. Because of its greater resistance to permanent deformation, the mix containing the PBA-6a* binder is planned for use as the surface course. A design binder content of 4.7 percent (by weight of aggregate) was selected for the estimated laboratory equivalent of 660,000 repetitions. Because of structural considerations, the AR-8000 mix was selected for the rest of the pavement section. Since it would likely be subjected to trafficking prior to placement of the PBA-6a* mix, a binder content of 4.7 percent was also selected to preclude premature rutting. The 146,000 repetitions shown in Figure 2 were the maximum equivalent laboratory repetitions that the AR-8000 mix would be expected to sustain prior to placement of the PBA-6a* mix.

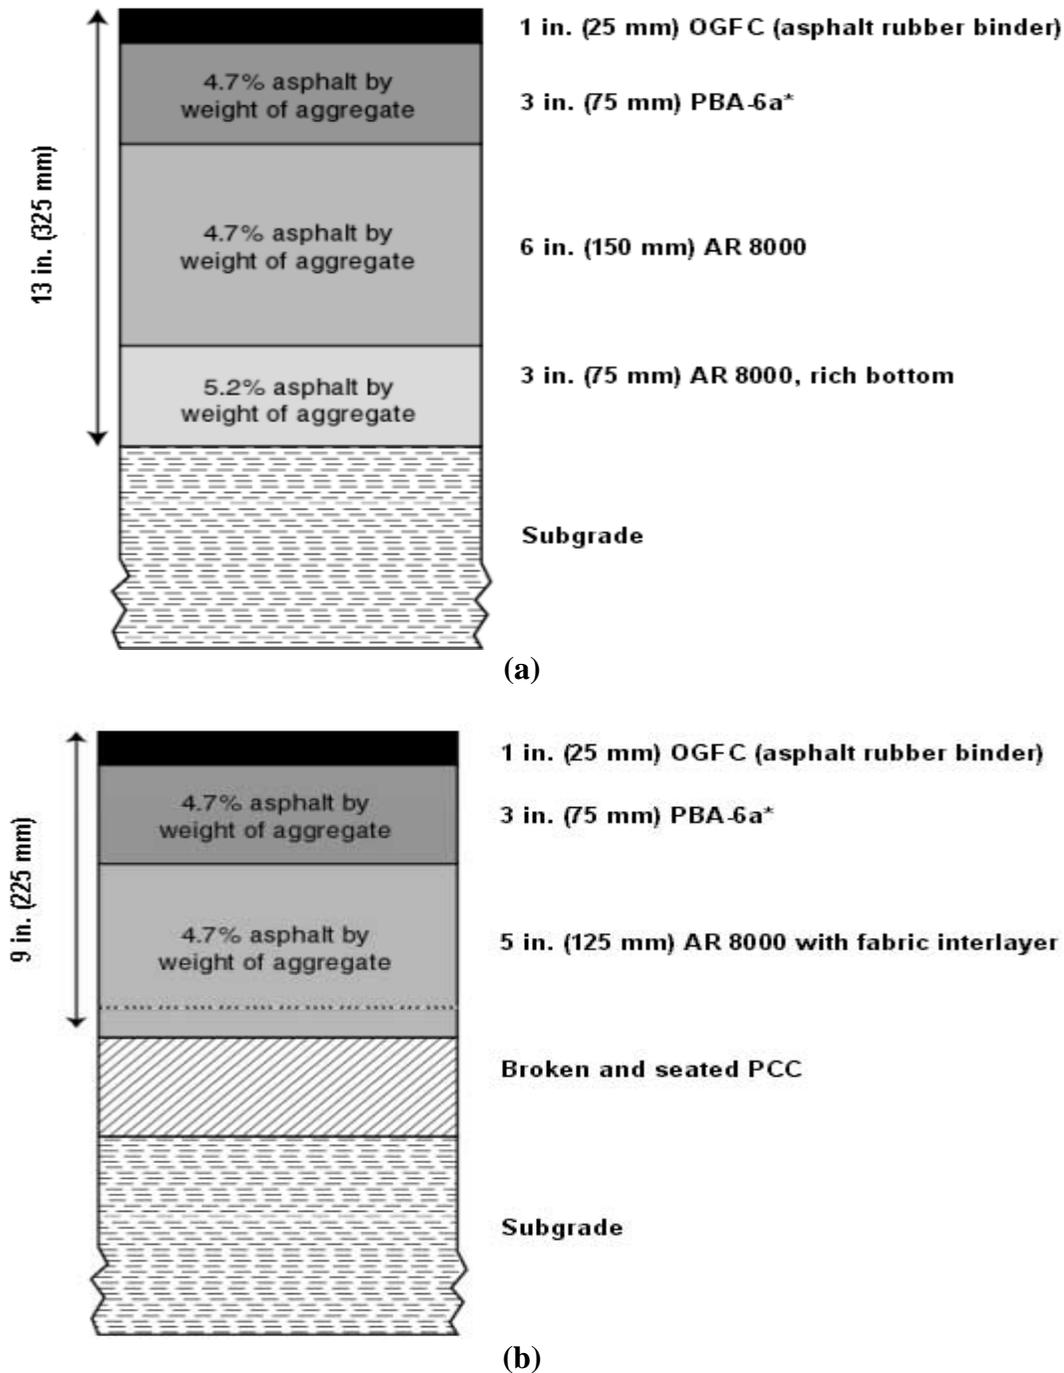
FIGURE 3 Proposed design for Interstate 710 rehabilitation: (a) replacement section and (b) overlay section.

For the overlay section, a finite element analysis was performed to select the total thickness above the cracked and seated existing PCC pavement. The resulting section is shown in Figure 3b. As seen in this schematic, the same materials as used in the full-depth replacement sections

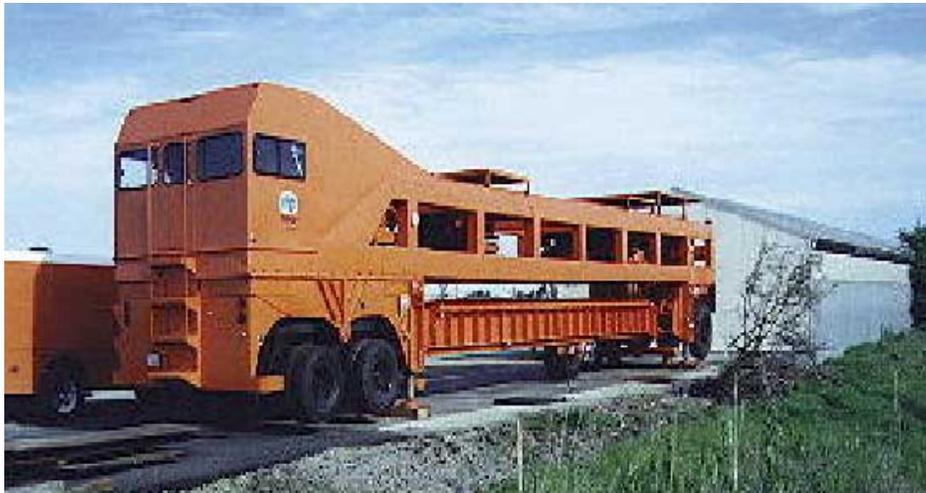
FIGURE 4 Heavy vehicle simulator.
