TRANSPORTATION RESEARCH
CIRCULAR

Perpetual Bituminous Pavements

TRB Committee on General Issues in Asphalt Technology (A2D05)

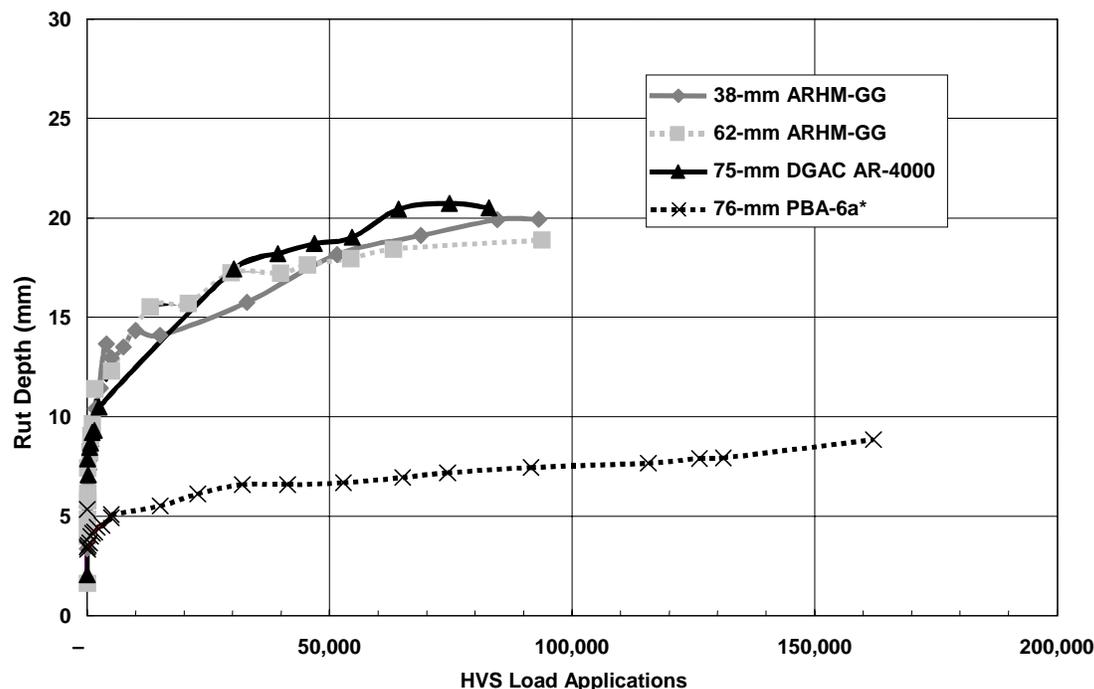
FIGURE 5 Rut depth versus HVS load applications with 40 kN load on dual tires at 50°C.

Results of the accelerated loading on the PBA-6a* mix carried to about 170,000 channelized repetitions are shown in Figure 5. Also shown in the figure are results obtained from an earlier study using both a dense-graded AC with AR-4000 asphalt cement (Stabilometer “S” value = 43) and an asphalt rubber gap-graded hot mix (Stabilometer “S” value = 23). It will be noted that the PBA-6a* mix performed significantly better in terms of rutting than the other two mixes (6).

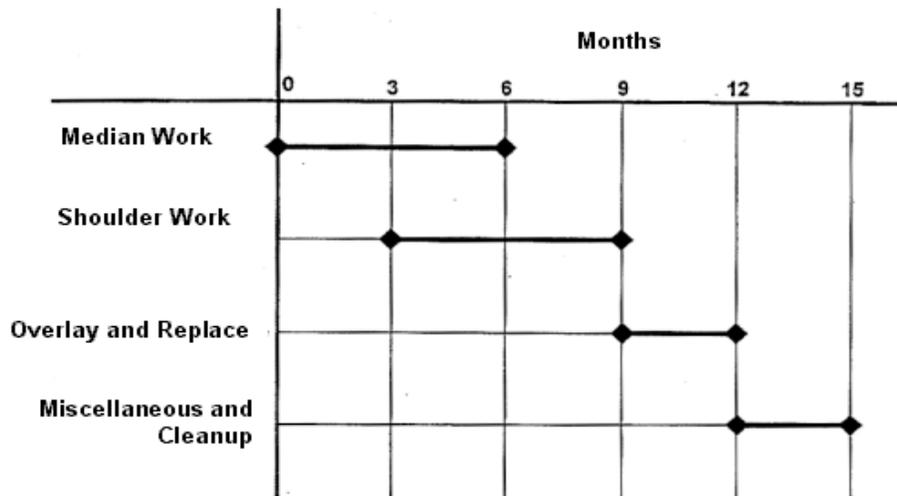
FIGURE 6 Staged rehabilitation construction schedule for I-710 project. (Source: 4th Meeting for Long-Life AC Pavement Rehabilitation Strategies with Caltrans and Southern California Asphalt Paving Association, June 11, 1999.)

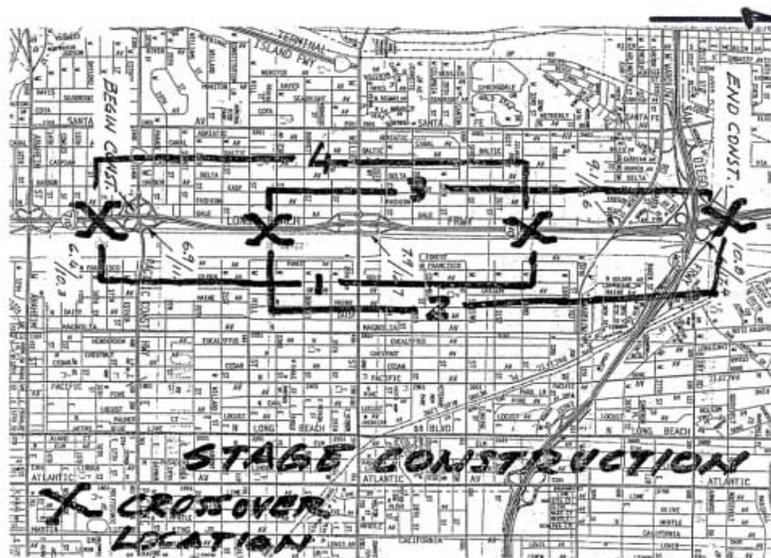
FIGURE 7 Site layout of the asphalt pavement project for I-710. (Source: 4th Meeting for Long-Life AC Pavement Rehabilitation Strategies with Caltrans and Southern California Asphalt Paving Association, June 11, 1999.)

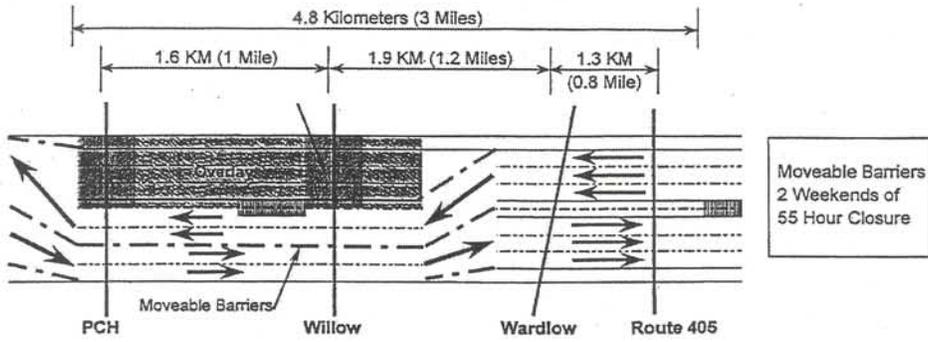
STAGE 3: Overlay & Replacement Willow Through PCH S/B

STAGE 3 - Use Moveable Barriers. Reconstruct S/B Pavement at PCH and Willow OC and overlay portion closed to traffic. Lower profile at PCH and Willow to provide Standard Vertical Clearance.

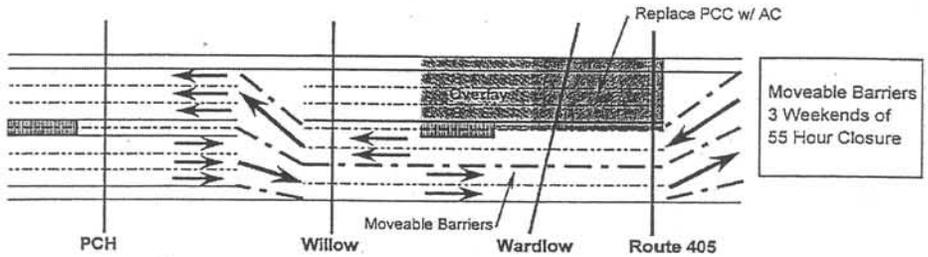
STAGE 4: Overlay & Replacement Rte 405 Through Wardlow S/B

STAGE 4 - Use Moveable Barriers. Reconstruct S/B Pavement at Route 405 and Wardlow OC and overlay portion closed to traffic. Lower profile at Wardlow OC and Rte 405 to provide Standard Vertical Clearance.

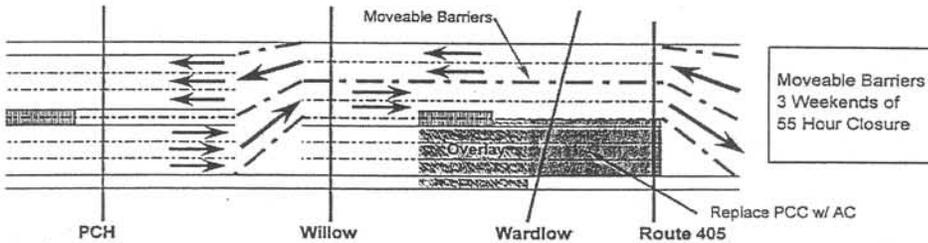
STAGE 5: Overlay & Replacement Wardlow Through Rte 405 N/B

STAGE 5 - Use Moveable Barriers. Reconstruct N/B Pavement at Route 405 and Wardlow OC and overlay portion closed to traffic. Lower profile at Wardlow OC to provide Standard Vertical Clearance.

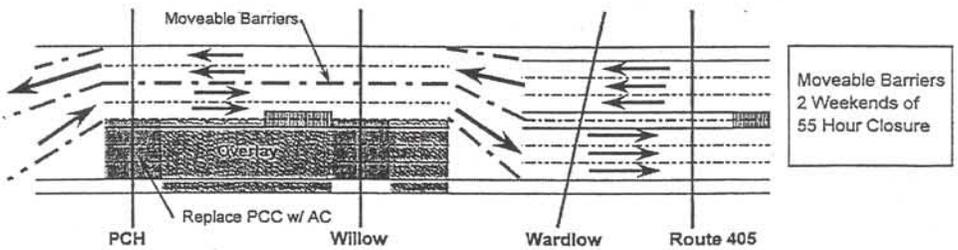
STAGE 6: Overlay & Replacement PCH Through Willow N/B

STAGE 6 - Use Moveable Barriers. Reconstruct N/B Pavement at PCH and Willow OC and overlay portion closed to traffic. Lower profile at PCH to provide Standard Vertical Clearance.

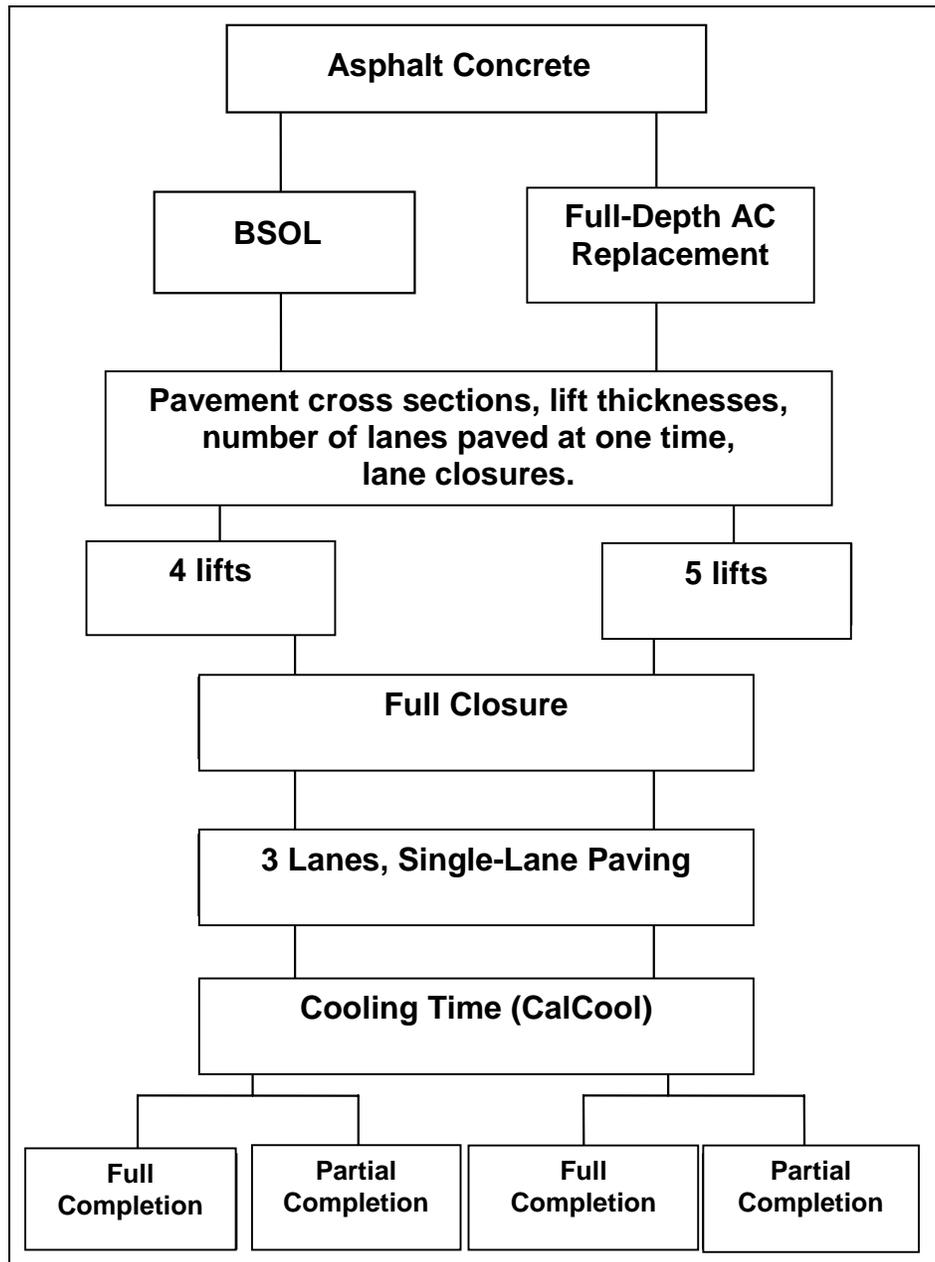
FIGURE 9 Analysis considerations, 55-hour closure constructibility program (summarized in Table 4).

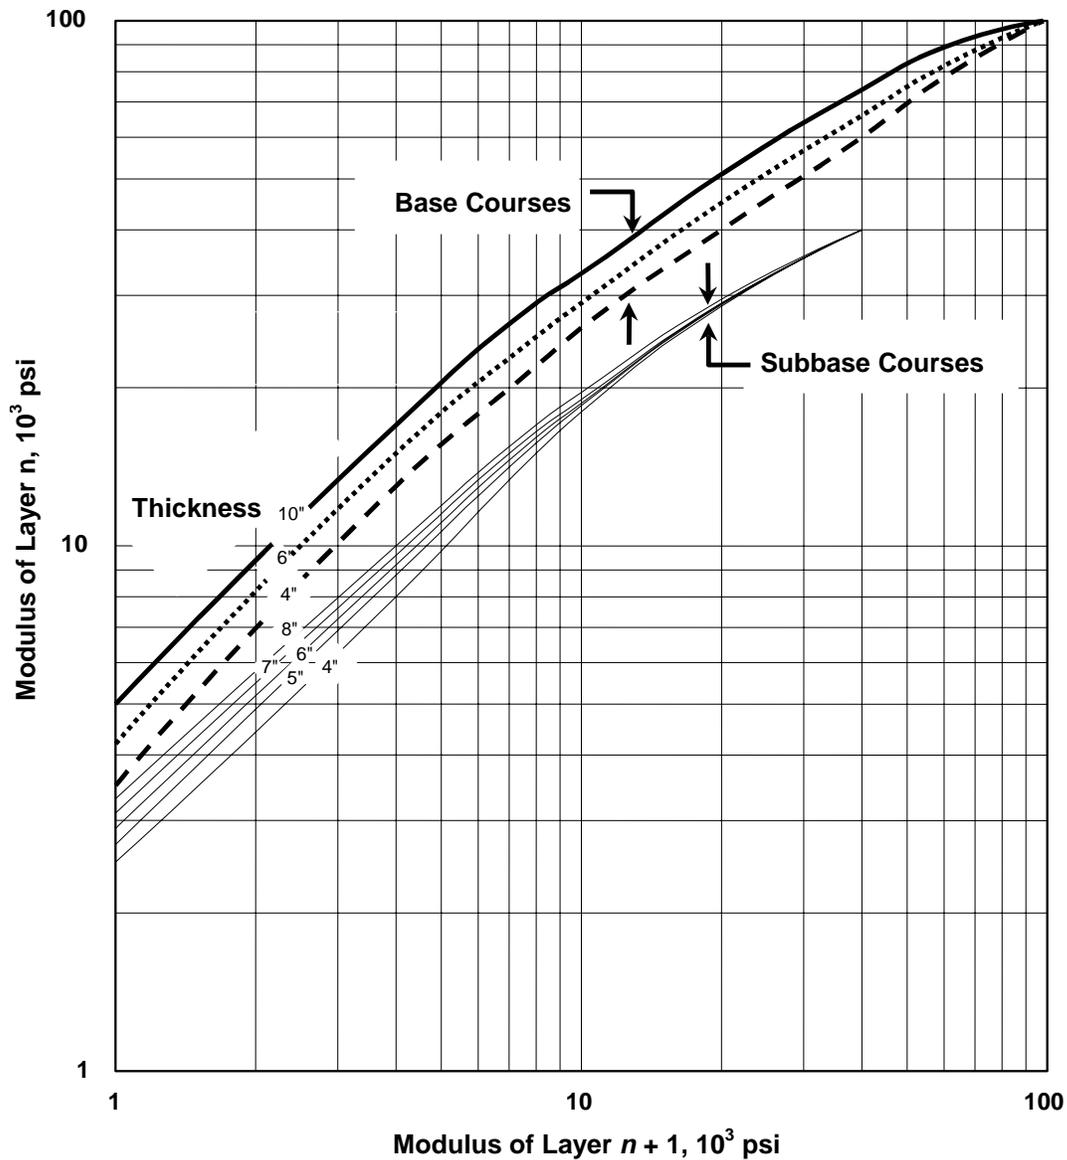
FIGURE 1 Limiting modulus criteria of unbound aggregate base and subbase layers (2) (1 in. = 0.0254 m; 10^5 psi = 698 MPa).

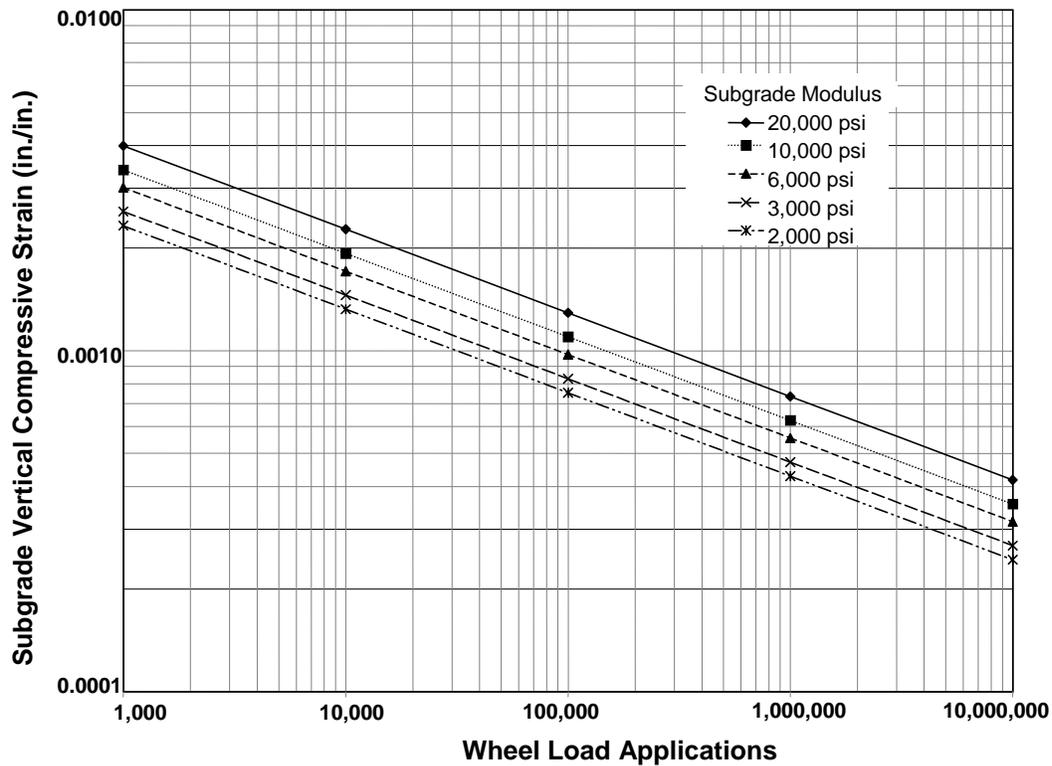
FIGURE 2 Relationship between subgrade vertical compressive strain and wheel load applications for the deformation failure criteria (2).

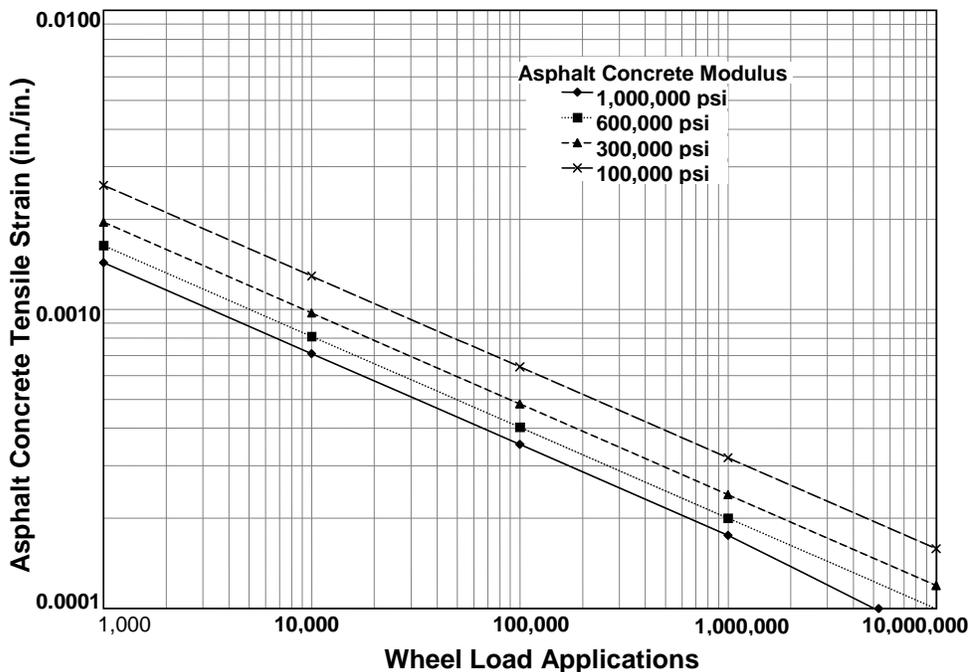
FIGURE 3 Relationship between asphalt concrete tensile strain and wheel load applications for the alligator cracking failure criteria (4).

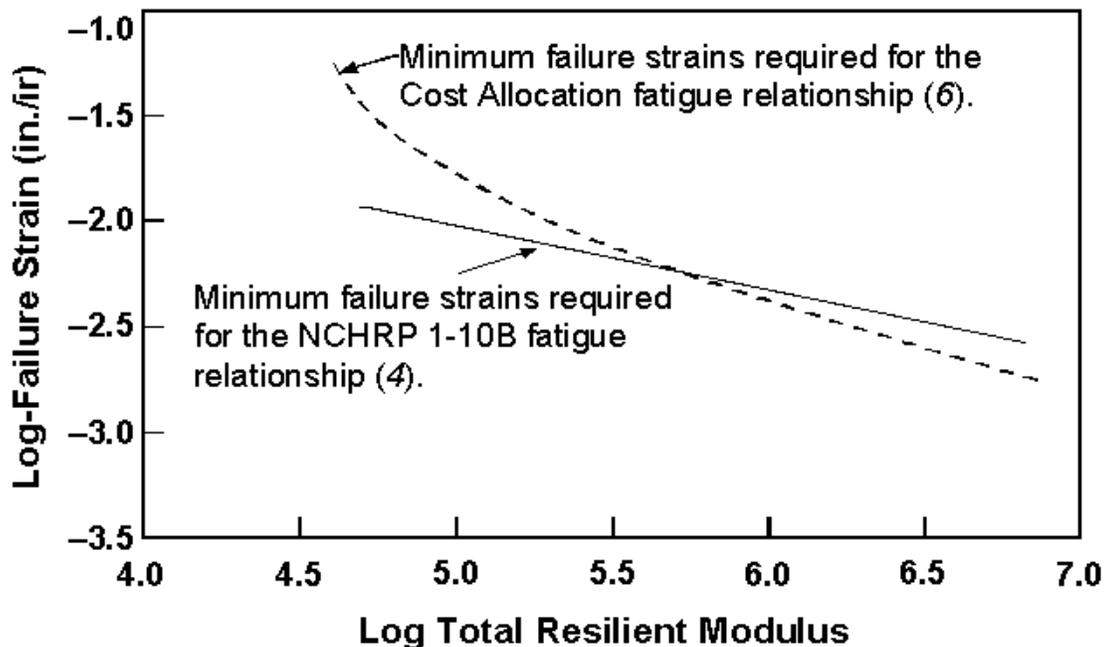
FIGURE 4 Relationship between the failure strain and total resilient modulus as measured using the indirect tensile test (6).

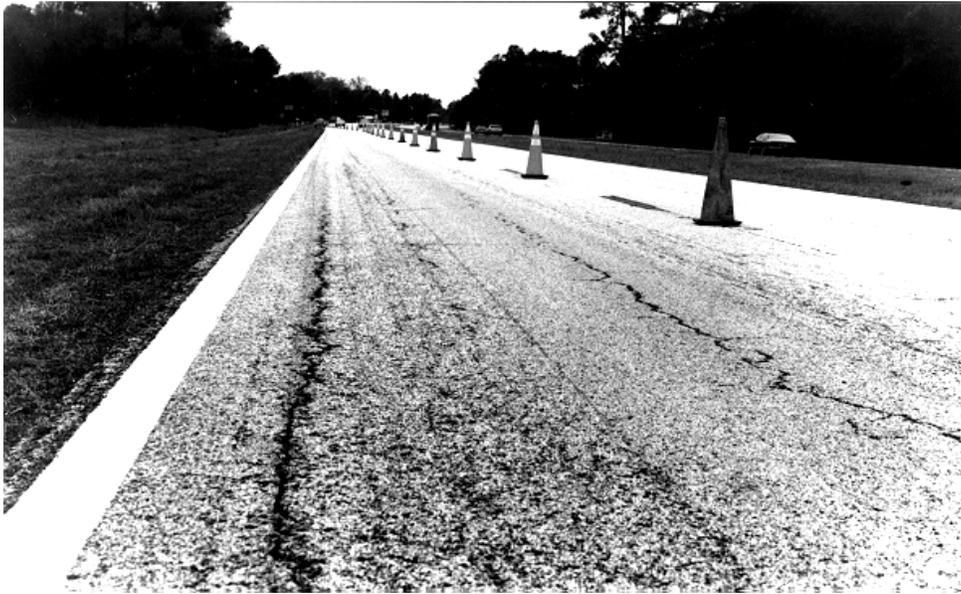
FIGURE 1 Lane exhibiting surface-initiated longitudinal cracks in both wheelpaths.

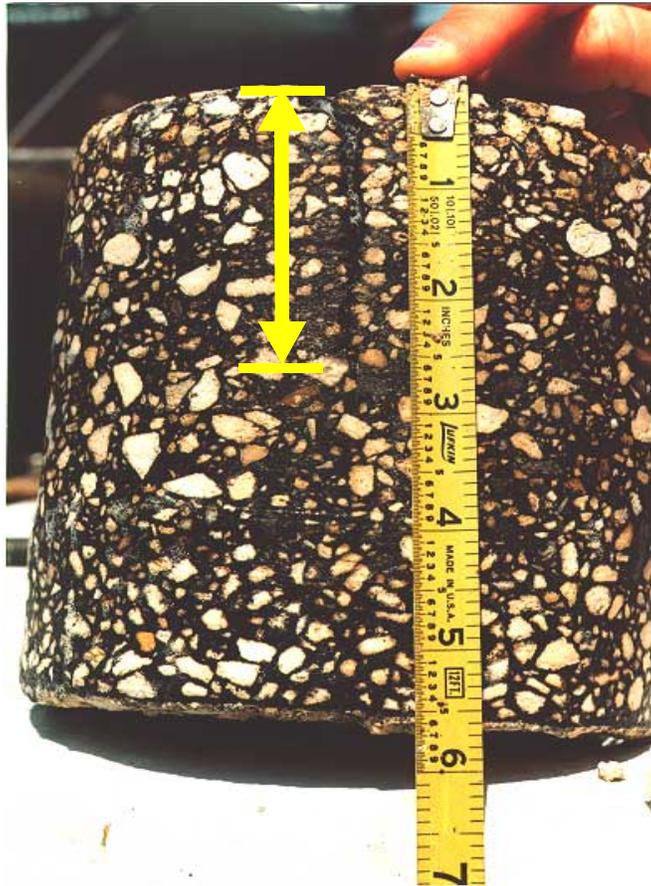
FIGURE 2 Core extracted from wheelpath illustrates crack opening at surface.

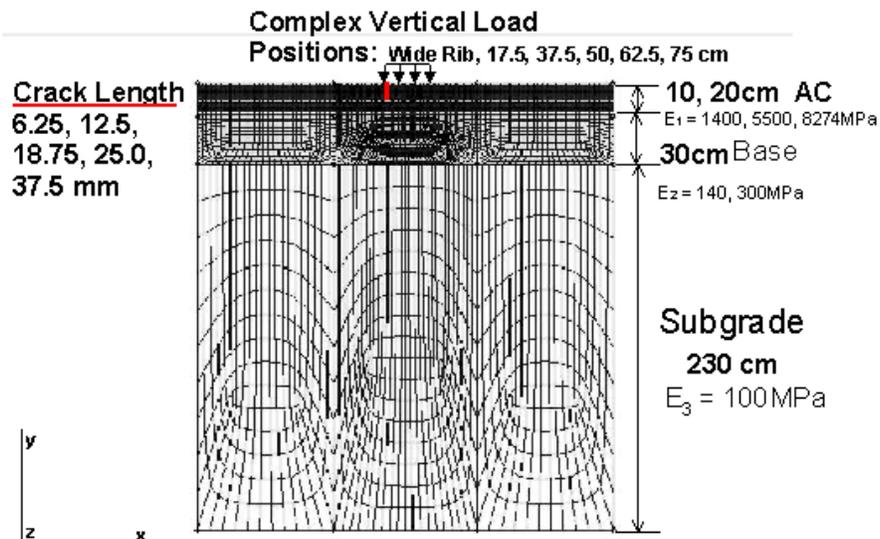
FIGURE 3 Pavement model showing parameters evaluated for identification of factors critical to propagation of surface cracking (AC = asphalt concrete, E = stiffness modulus).

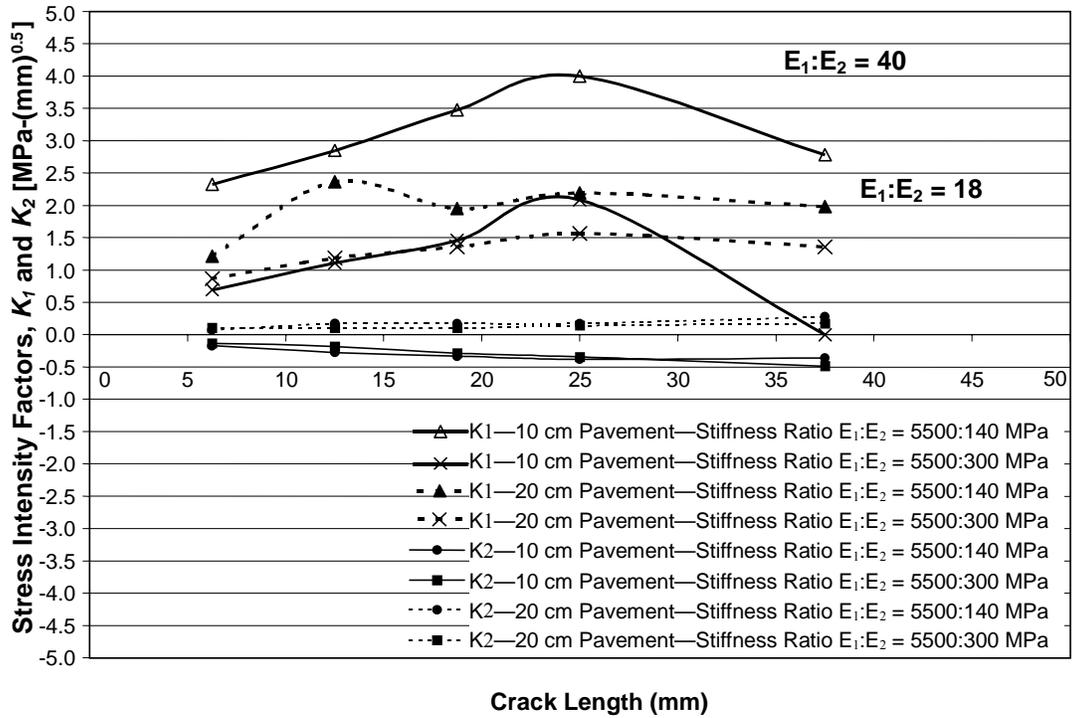
FIGURE 4 Comparison of failure modes: magnitude of tensile fracture (K_I) versus shear fracture (K_{II}) for one loading case (62.5 cm from crack).

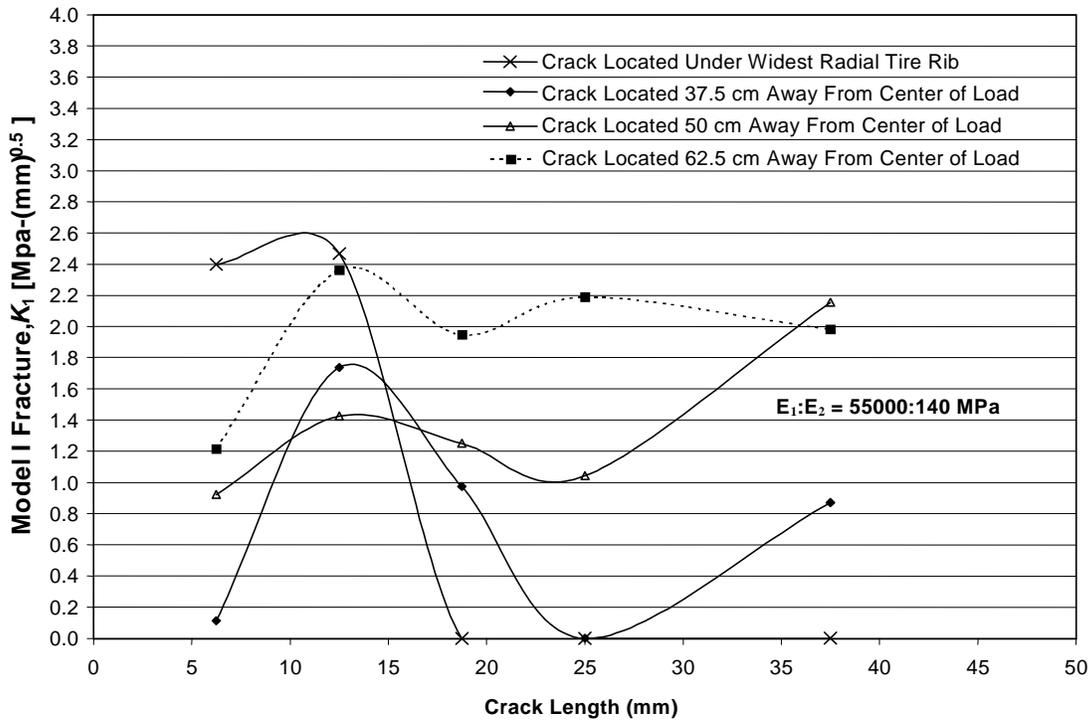
FIGURE 5 Effect of load positioning on opening at the crack tip for 20-cm surface layer with a high stiffness ratio.

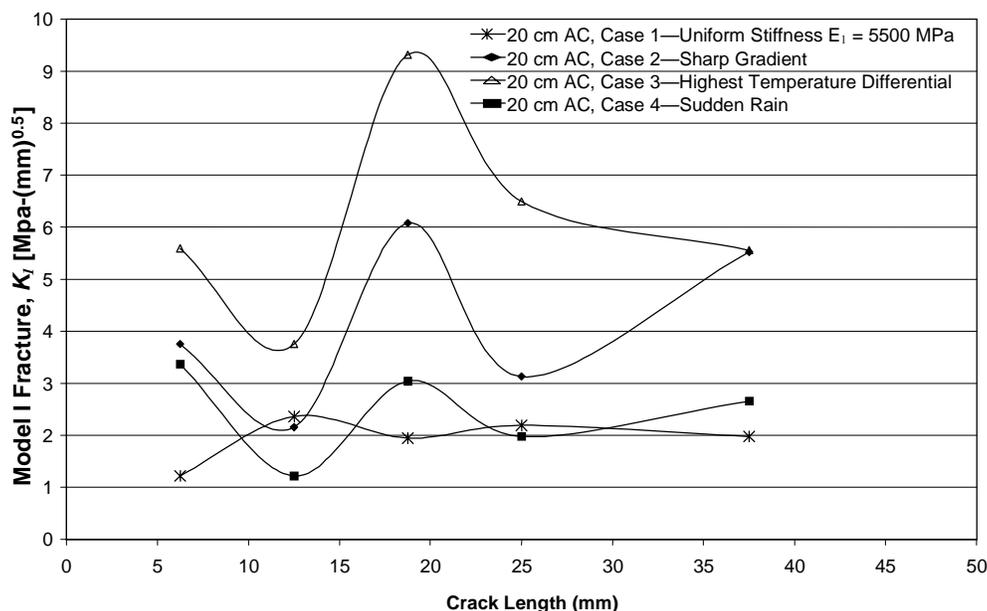
FIGURE 6 Effect of temperature-induced stiffness gradients on stress intensity K_I predicted at crack tip for 20-cm AC (load centered 75 cm from crack; base stiffness $E_2 = 140$ MPa; AC = asphalt concrete).

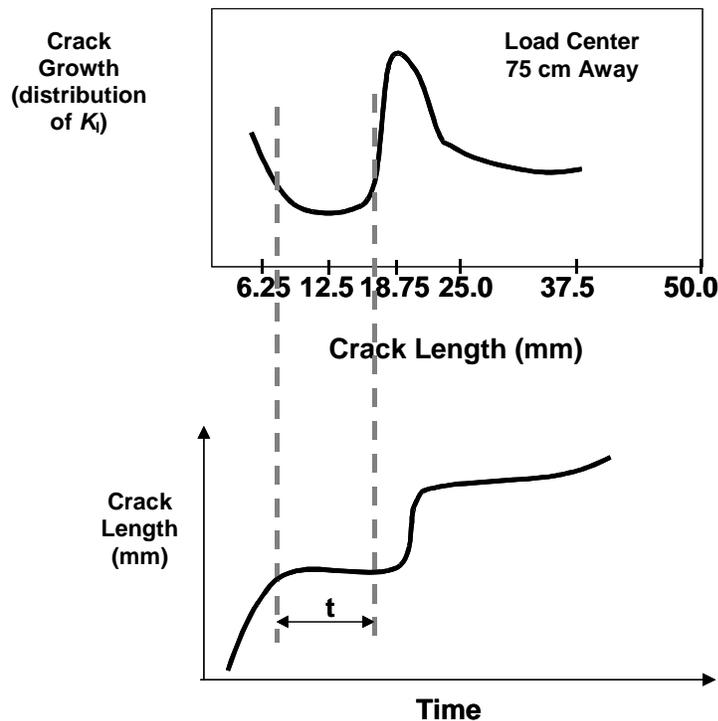
FIGURE 7 Potential for crack growth and time available for identification and rehabilitation for 20-cm pavement and given load spectrum. (t = time available for identification and rehabilitation.)

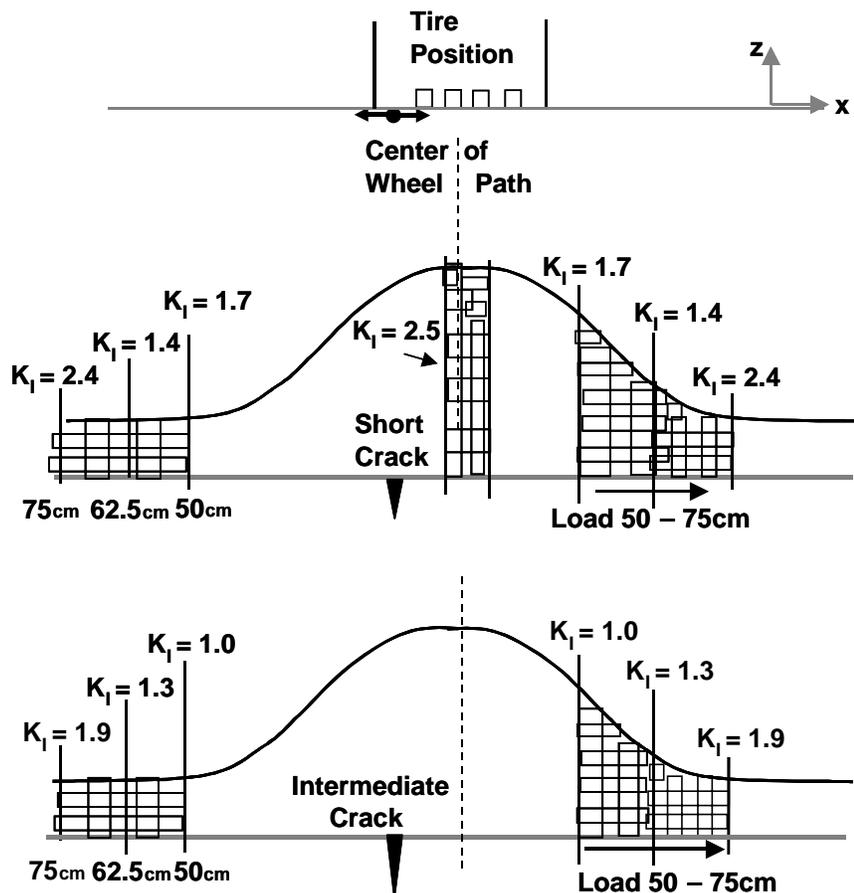
FIGURE 8 Transverse distribution of load within wheelpath and critical load positions for cracking in a 20-cm asphalt concrete layer of uniform stiffness (E_I). [AC = asphalt concrete; fracture stress intensity (K_I) in MPa (mm)^{0.5}]

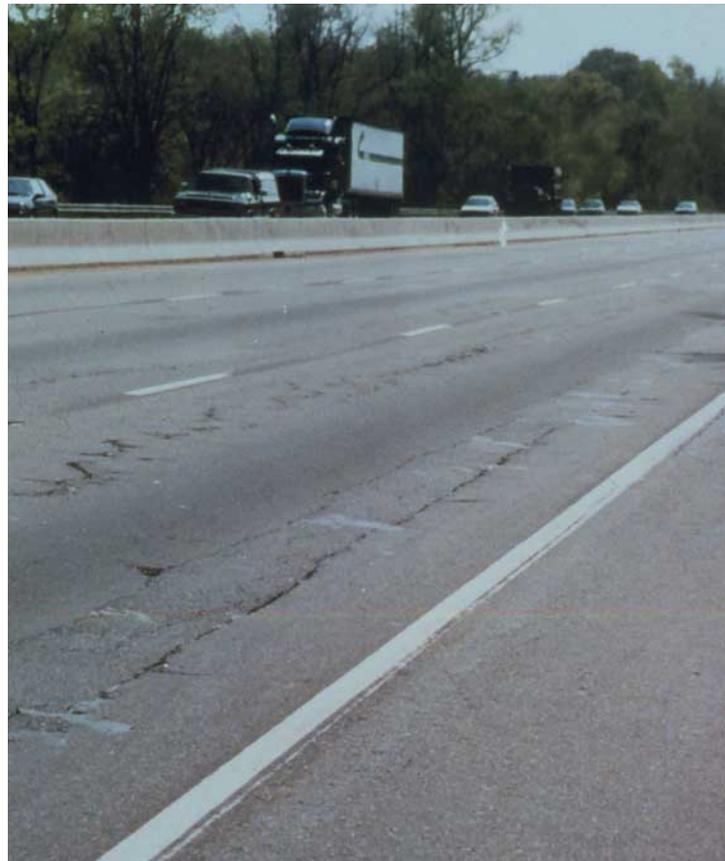
FIGURE 2 Typical surface appearance, 1993.

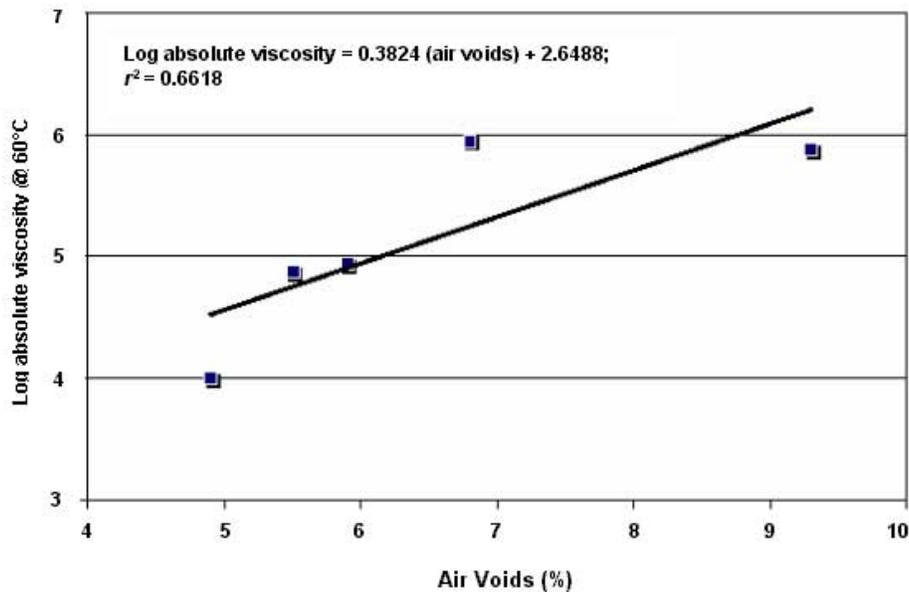
FIGURE 5 Log absolute viscosity versus air voids.

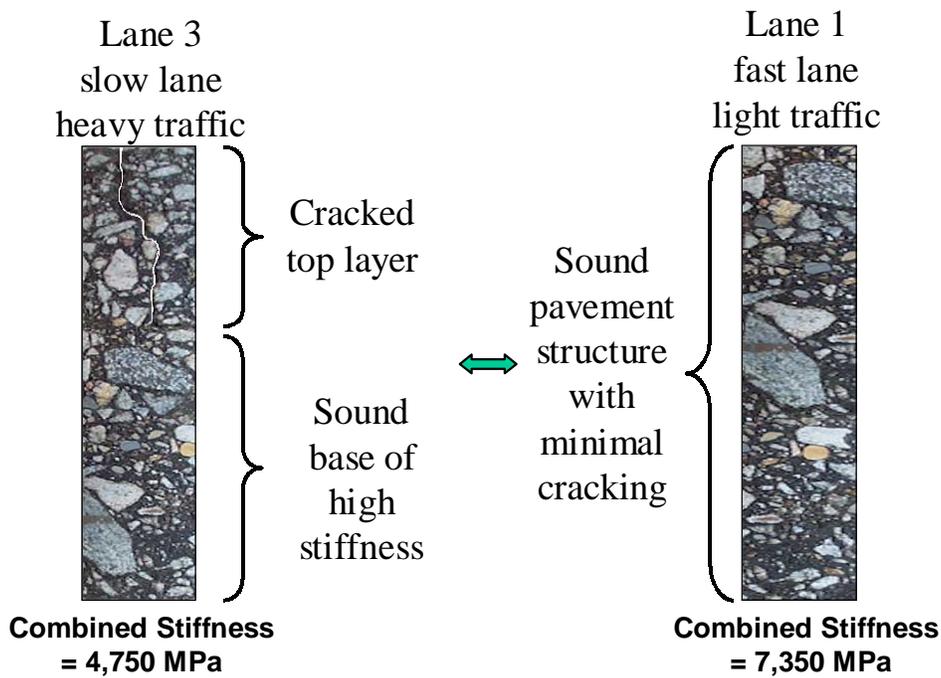
FIGURE 6 Average FWD results. [Combined stiffness refers to the stiffness modulus obtained from back analysis when the asphaltic layers (base and wearing course) have been combined into a single layer.]

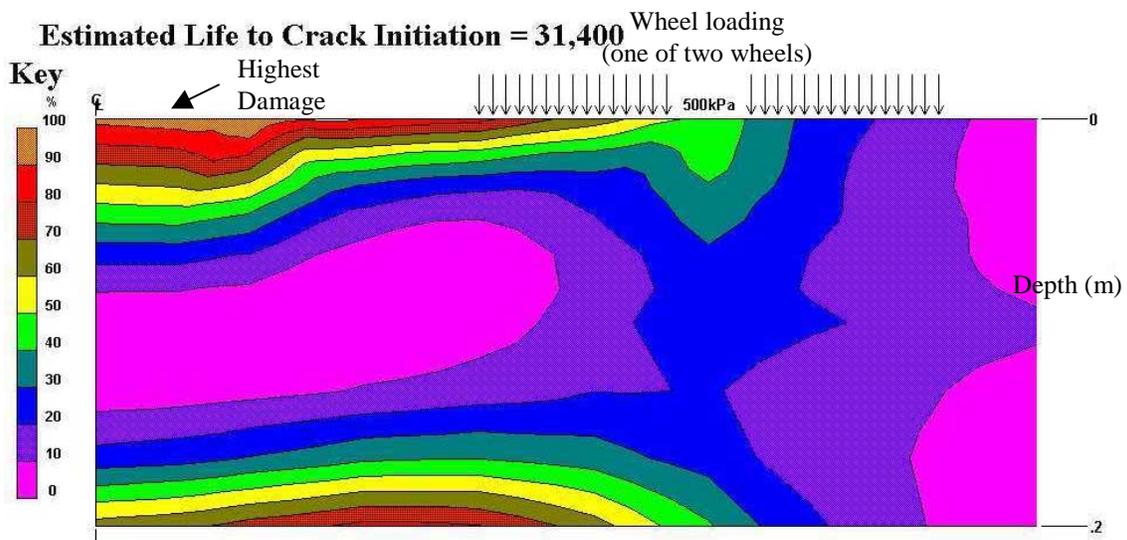
FIGURE 7 Surface-cracking calculations: pavement of 8 in. dense bitumen macadam with applications of a 40-kN duell wheelload; contours of relative (percent) fatigue damage; cross section from center line of loaded area with position of one wheel indicated (3).

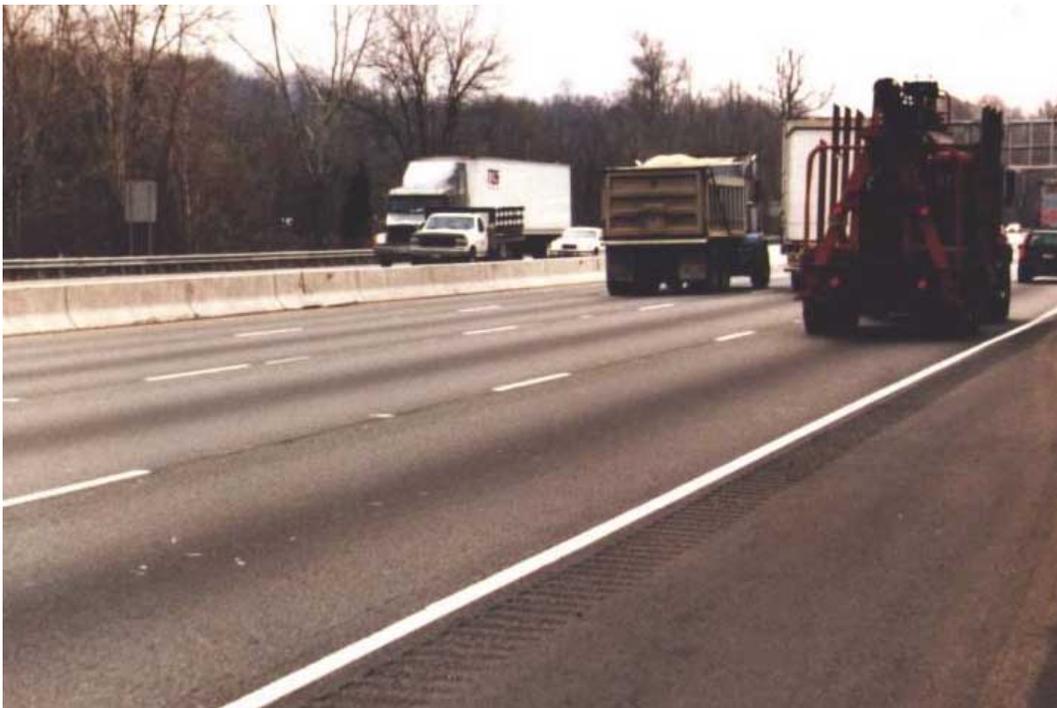
FIGURE 8 Current condition.

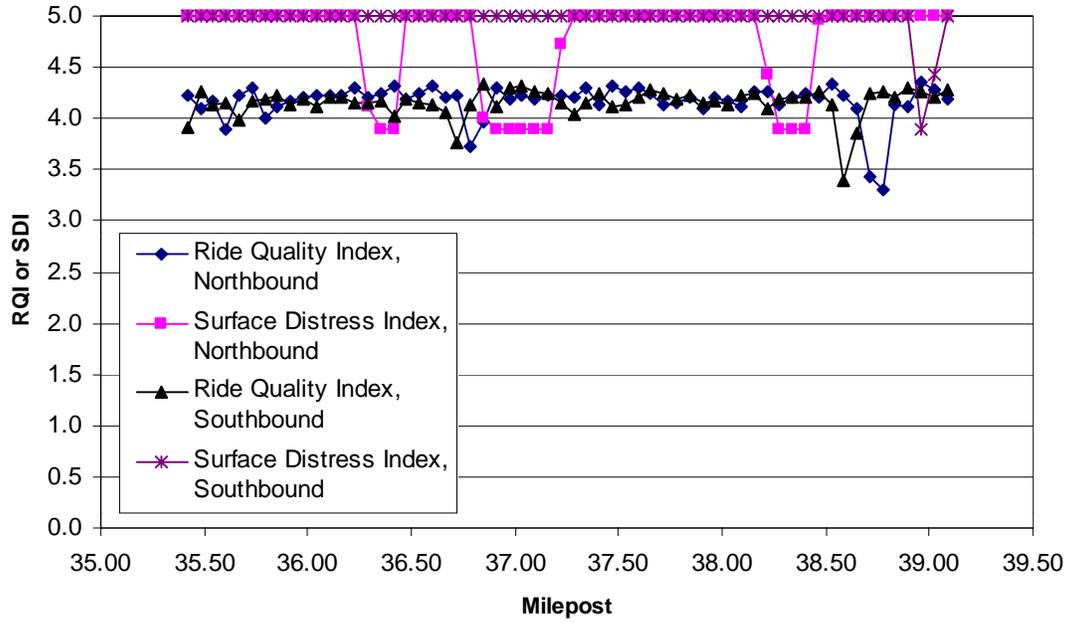
FIGURE 9 Pavement ratings (RQI and SDI) versus Milepost I-287.

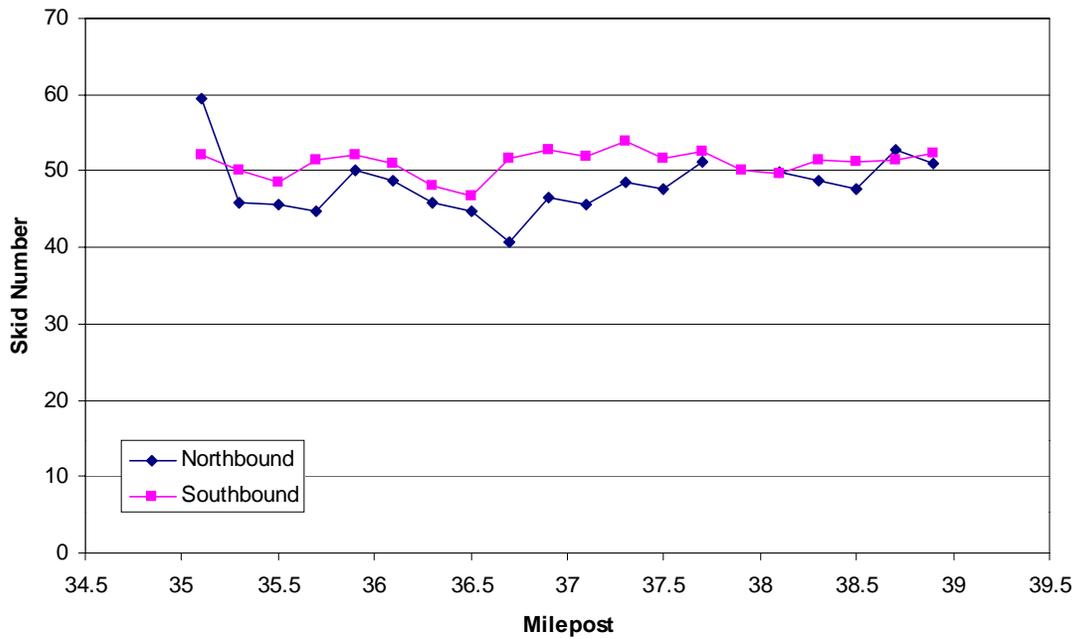
FIGURE 10 Skid numbers versus Milepost I-287.
